PUBLIC WORKS DEPARTMENT

MAYOR: Lauren McLean | DIRECTOR: Stephan Burgos

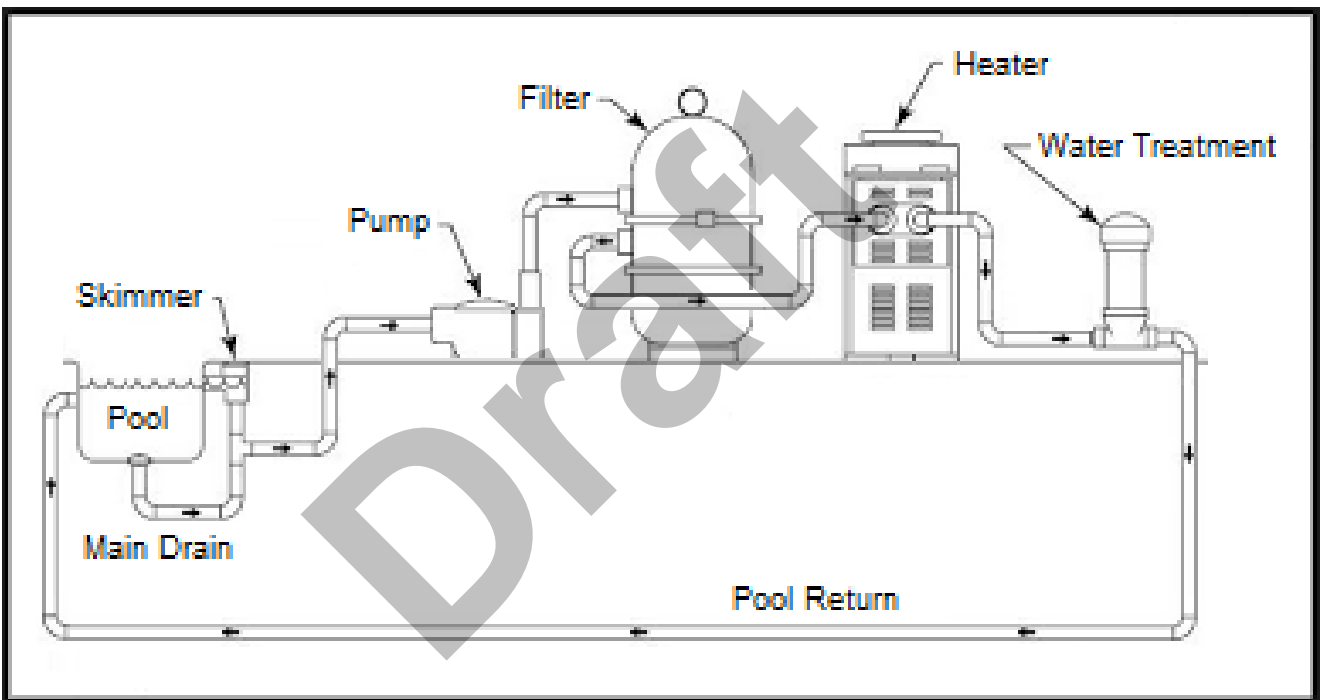
Simplified Diagram of Pool Mechanical System

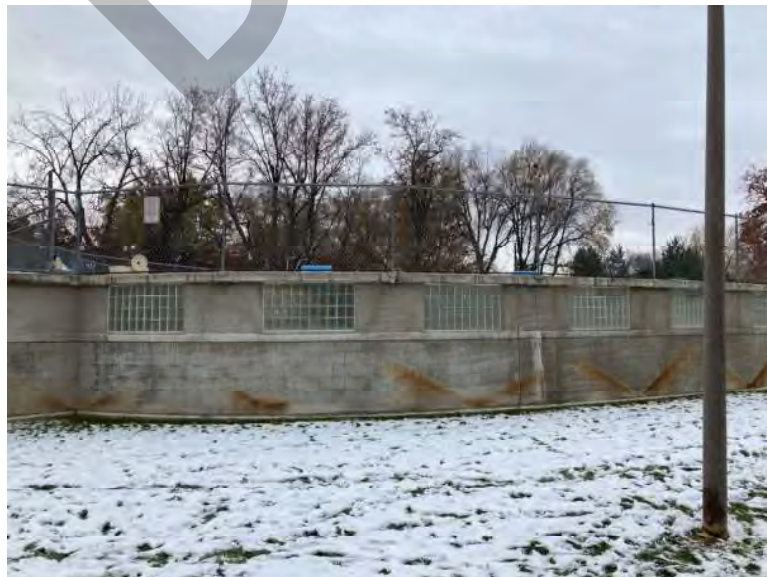
Exterior façade – showing water staining and deteriorating/aging skim coat on the CMU block. Chain-link fencing shown above.

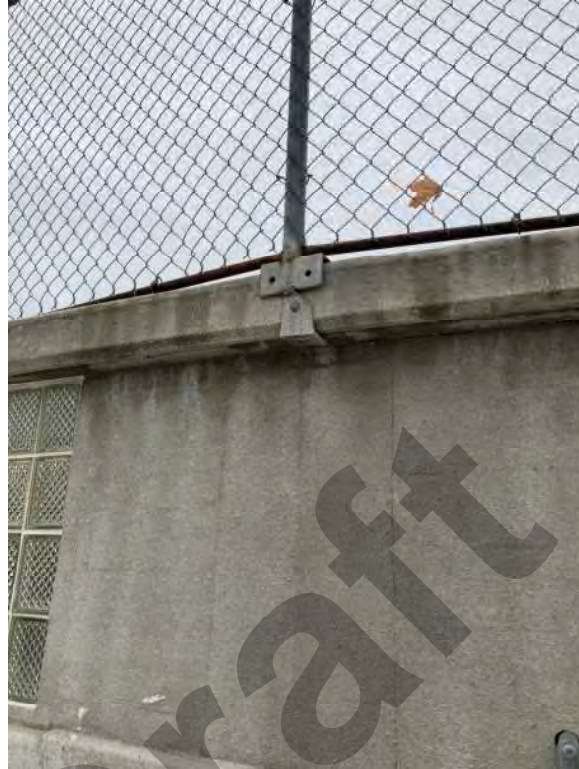
Fence post attachment to concrete edge.

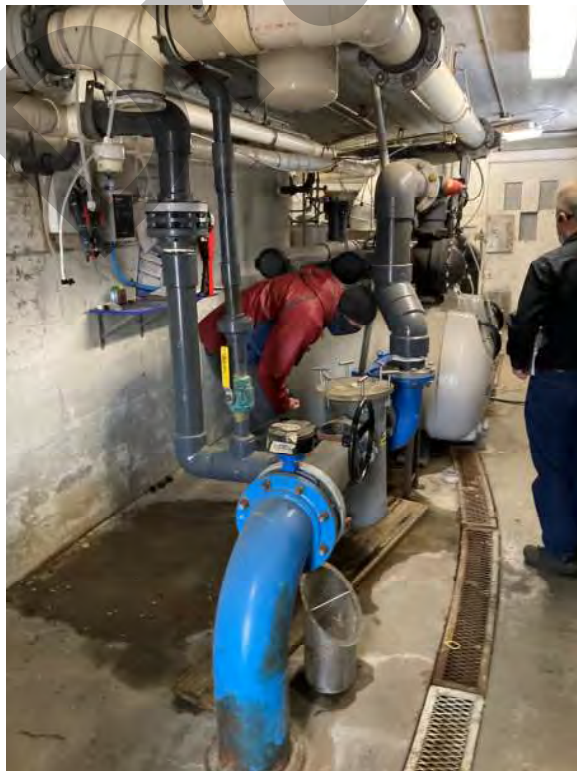
Pool pump room. Shows rusted floor grating.

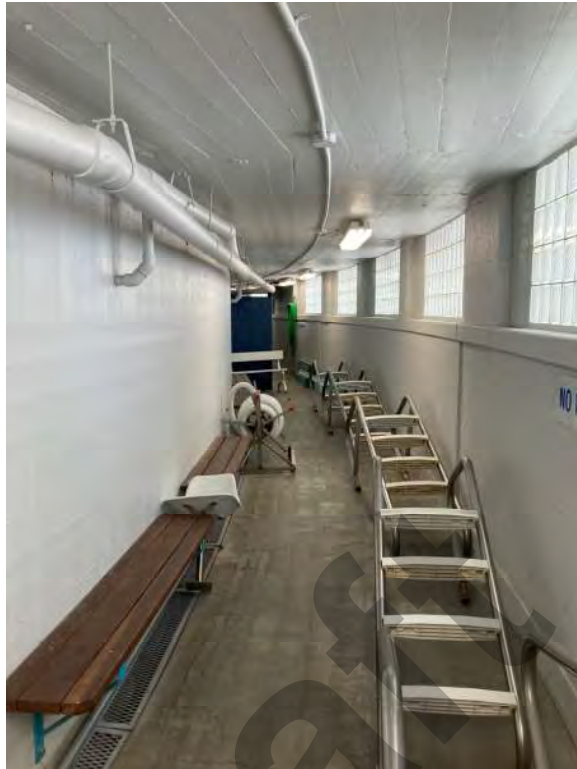
Men's changing room.

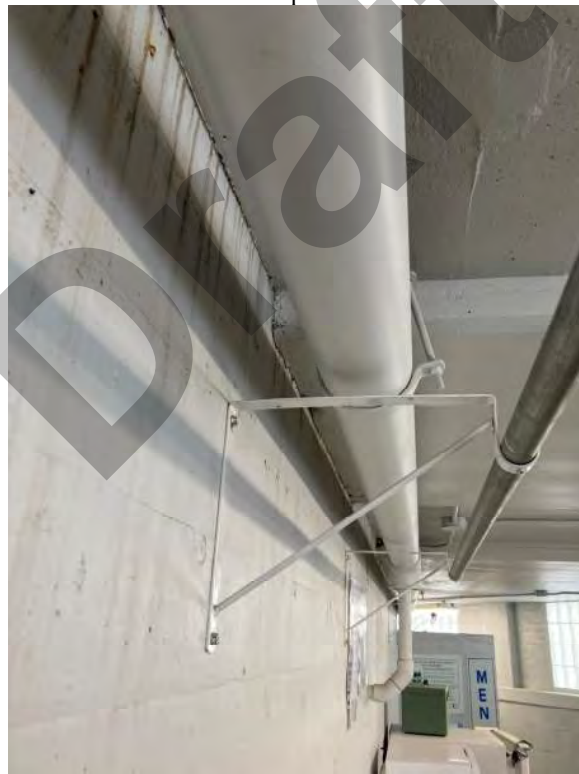
Staining and water leaking showing at slab and wall joint.

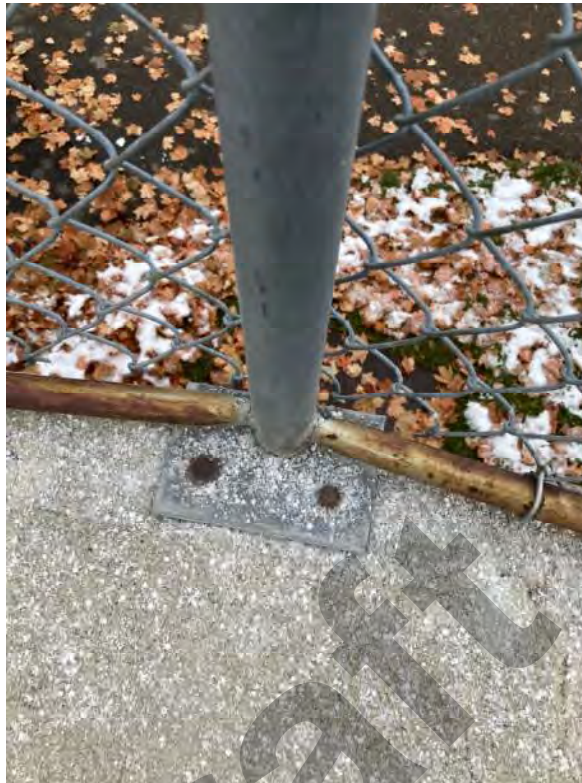
Rusted fence piping and bolt connections shown at fencing.

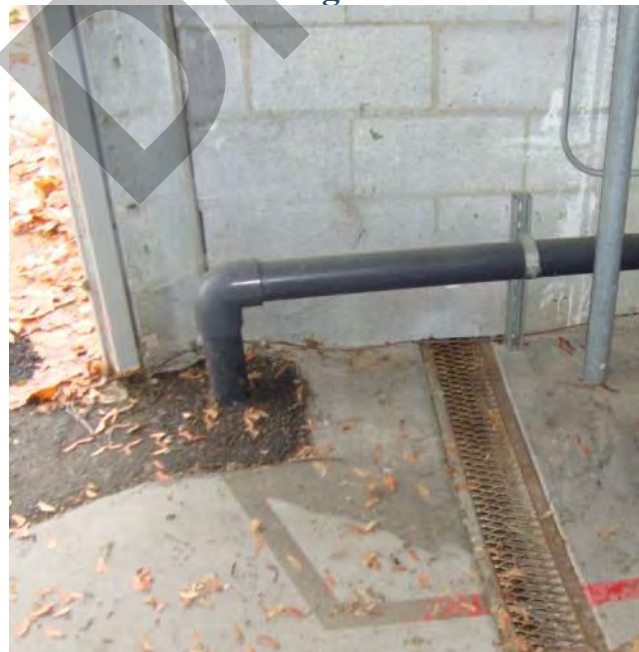
South Domestic Water Service Entrance.

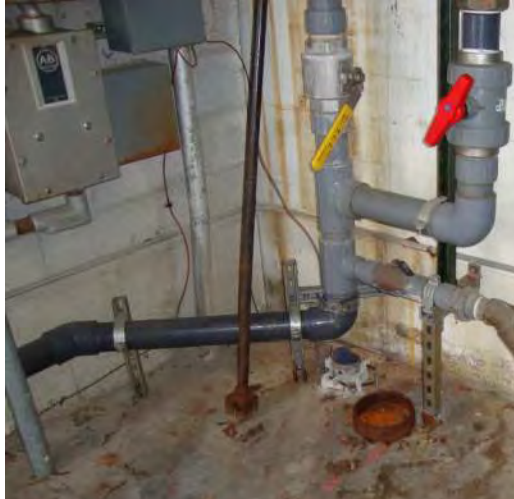
South Domestic Water Service Entrance (Section of Underground Piping Replaced with Plastic).

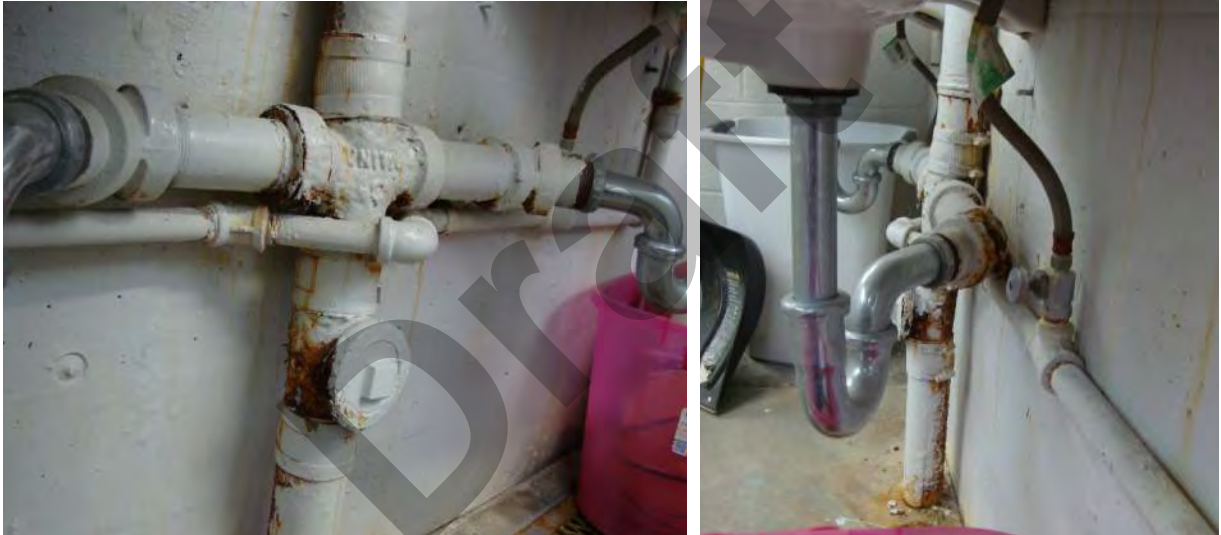
South Domestic Water and DWV Piping.

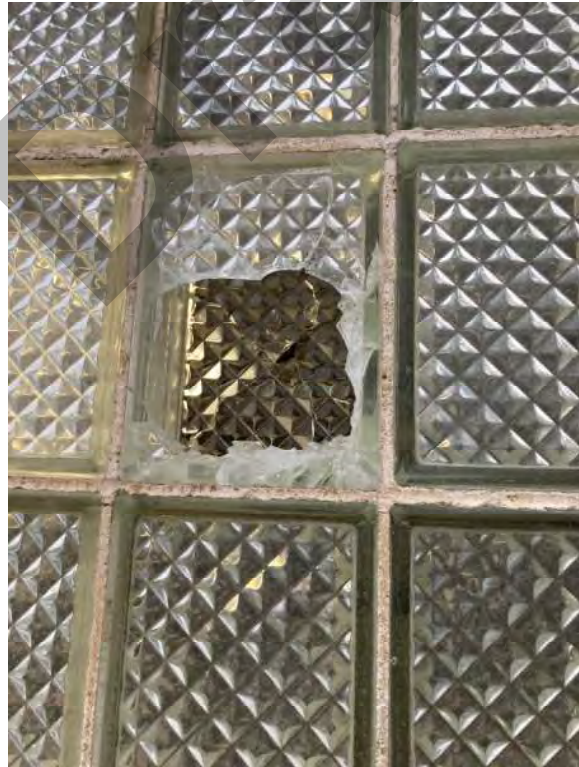
Glass block cracked and damaged.

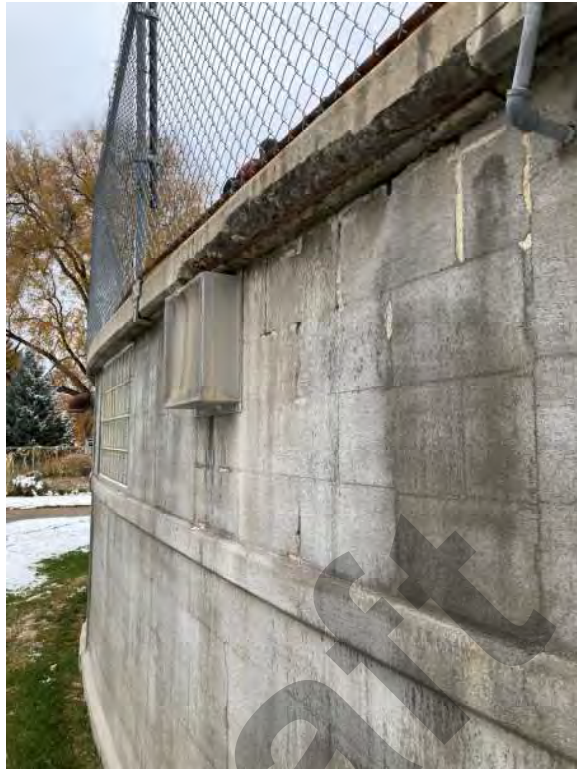
Concrete cracking and exposed rebar at deck edge.

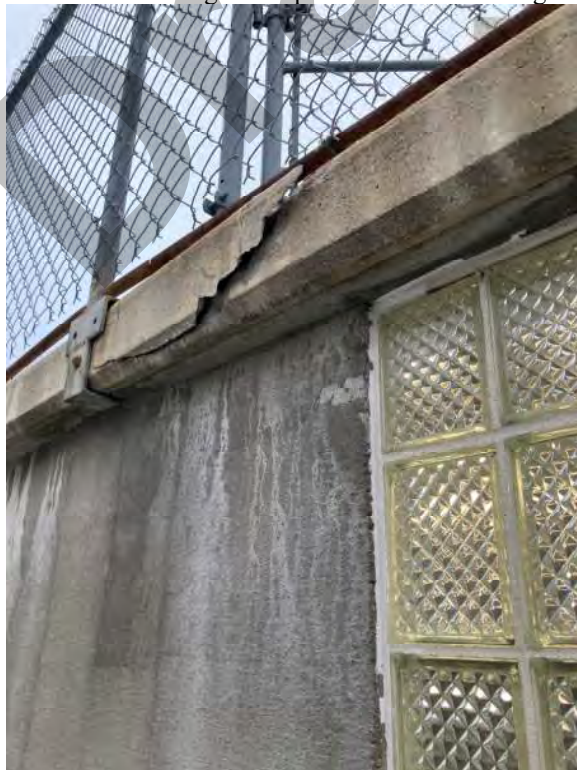
Concrete cracking at deck edge.

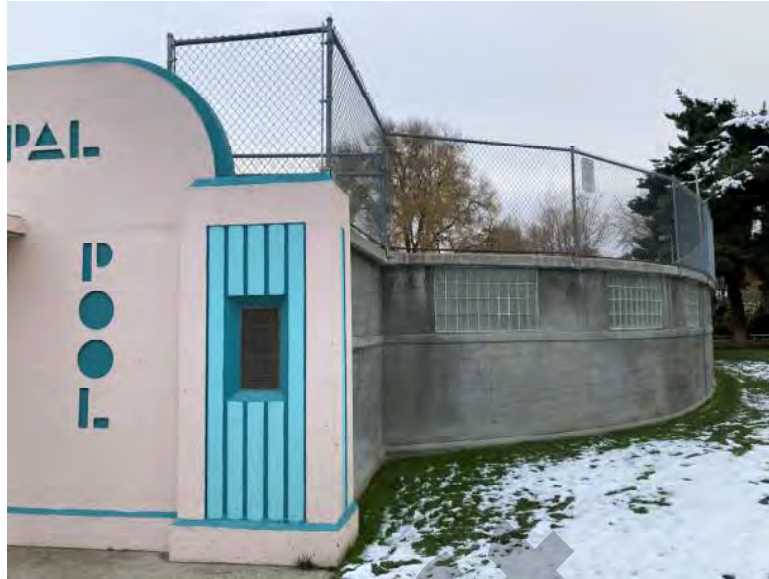
Exterior façade – showing deteriorating/aging skim coat on the CMU block. Chain-link fencing shown above.

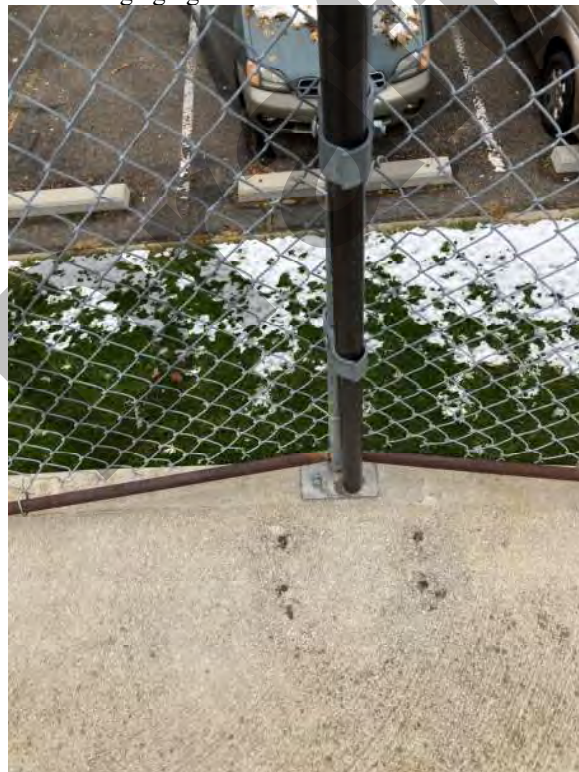
Rust showing at bottom of fence piping.
