City of Boise
ADA Assessment

Lowell Pool

11/20/2020

Report #TO20-B004

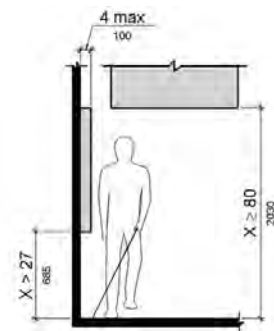
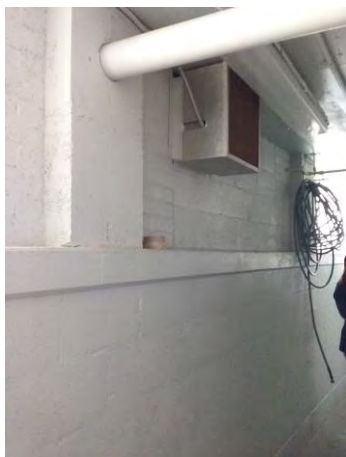
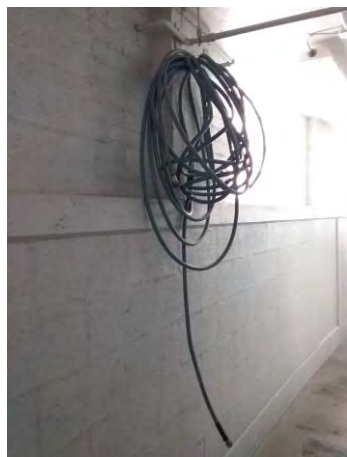
The hose protrudes 6" into the circulation space at 63" above the floor.
The air conditioning unit protrudes 7" into the circulation space at 78" above the floor.

Recess the hose and air conditioning unit so they protrude a maximum of 4", lower them so the bottom edge is 27" maximum above the floor, or place a cane detectable object beneath it.
