# FACILITIES ASSESSMENT

## South and Lowell City Pools

Structural Assessment February 2022

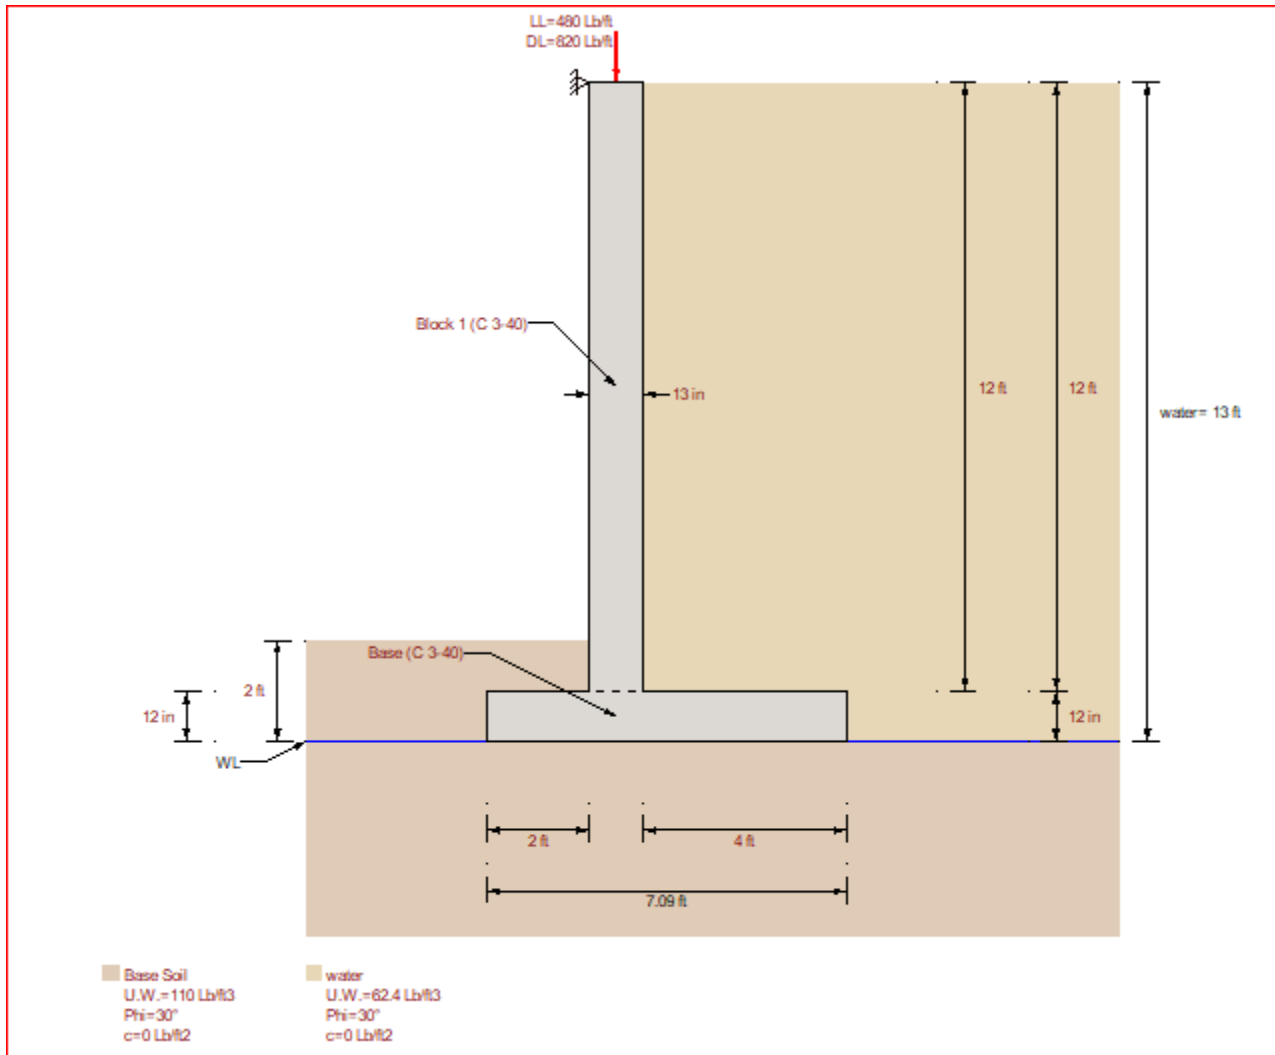
Figure 4: 2D View of Ram Elements Design Model of Concrete Pool Wall

The concrete pool wall was conservatively evaluated as a retaining wall in Ram Elements software, retaining 12 ft of water. The wall was modeled based on the field investigation, with appropriate thickness, height, and rebar. Applicable dead and live loads were incorporated into the model, along with lateral loads from water. Although findings indicate that pool deck and pool wall do not appear to be positively attached with reinforcing, it was still assumed that the pool deck braced the wall at the top, hence a pin-pin wall system. Based on the analysis, the pool wall meets design capacity, in which shear and moment capacities were not exceeded. Moreover, longitudinal reinforcement provided exceeded the minimum required by ACI code ( $0.0015xAg = 0.23 \text{ in}^2/\text{ft} < 1.2 \text{ in}^2/\text{ft}$ ), as well as the spacing of rebar (18'' max). Also, transverse rebar provided exceeded the minimum required by ACI code ( $0.0025xAg = 0.39 \text{ in}^2/\text{ft} < 3.6 \text{ in}^2/\text{ft}$ ), as well as the spacing of rebar (18'' max). In addition, the pool wall was checked in EnerCalc as a concrete beam against impulsive and convective seismic forces (see figure 5). Both loads were applied in conjunction with a lateral load due to the water in the pool. As such, the pool wall was confirmed to have adequate strength and passed all checks required in terms of strength and serviceability.

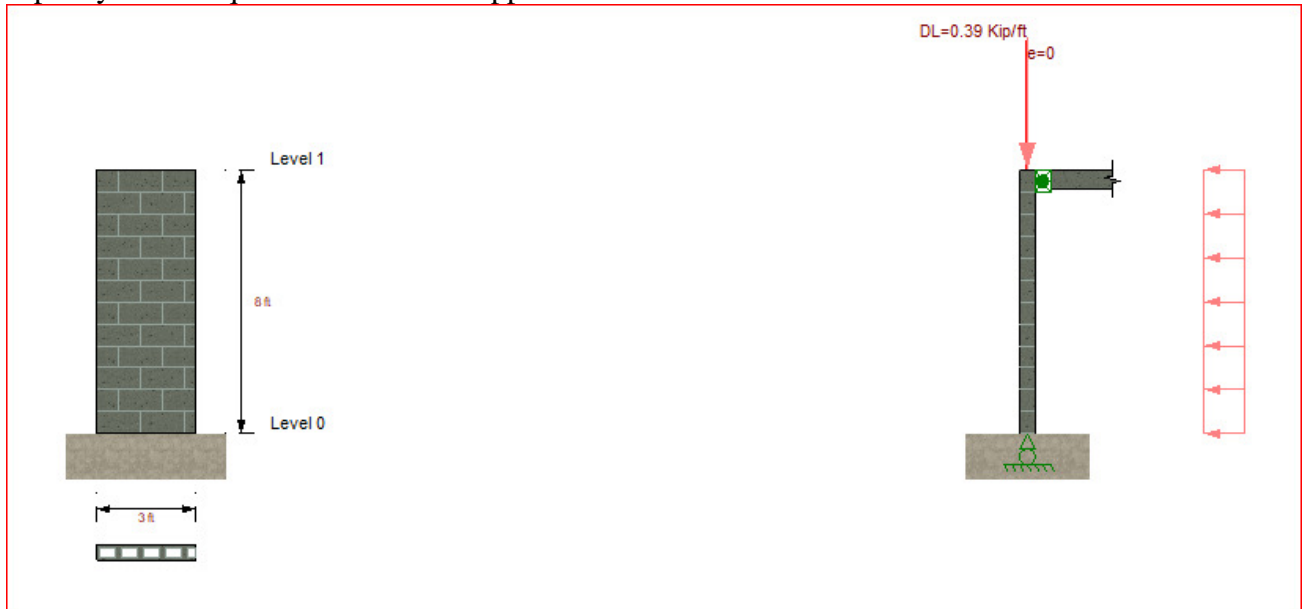
**Figure 6: 2D View of Ram Elements Design Model of Outer CMU Wall**

The outer CMU wall was evaluated for gravity and out of plane loads in Ram Elements software as an 8 ft tall wall, pinned at top and bottom. Based on field investigation and existing drawings, the CMU wall is a 6'' hollow unreinforced wall. In addition to dead and live loads, a 19.2 psf out-of-plane lateral wind load was applied based on ASCE 7-10 freestanding wall section. The wall's capacity was adequate to sustain the applicable loads.

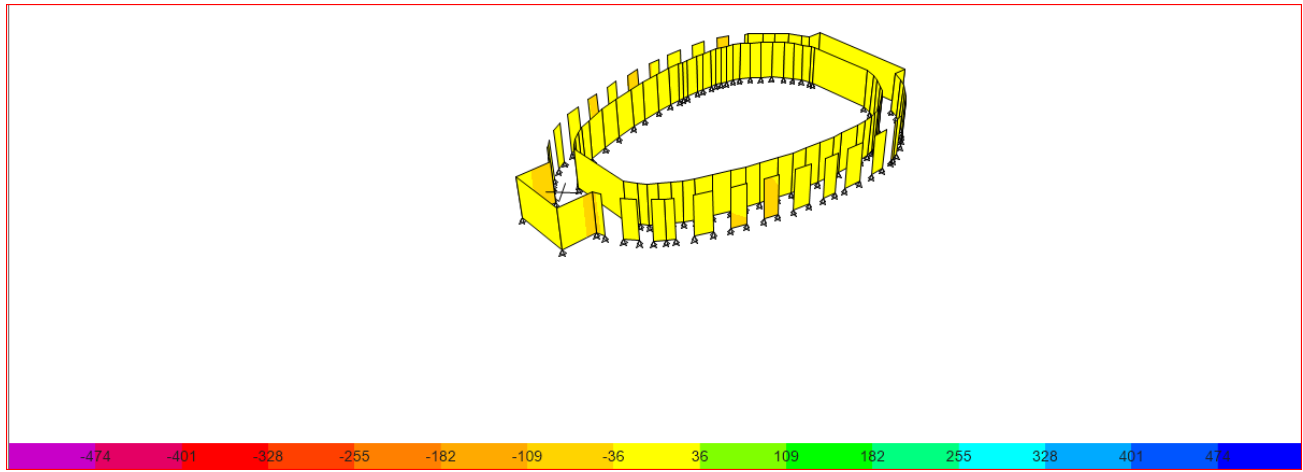
**Figure 8: 3D View of ETABS Design Model of Wall Stresses due to Applicable Loads**

Based on this finite element analysis, the existing walls of the pool were found to have adequate strength as the pool walls are below threshold level stresses that would cause the walls to experience cracking and deformation.

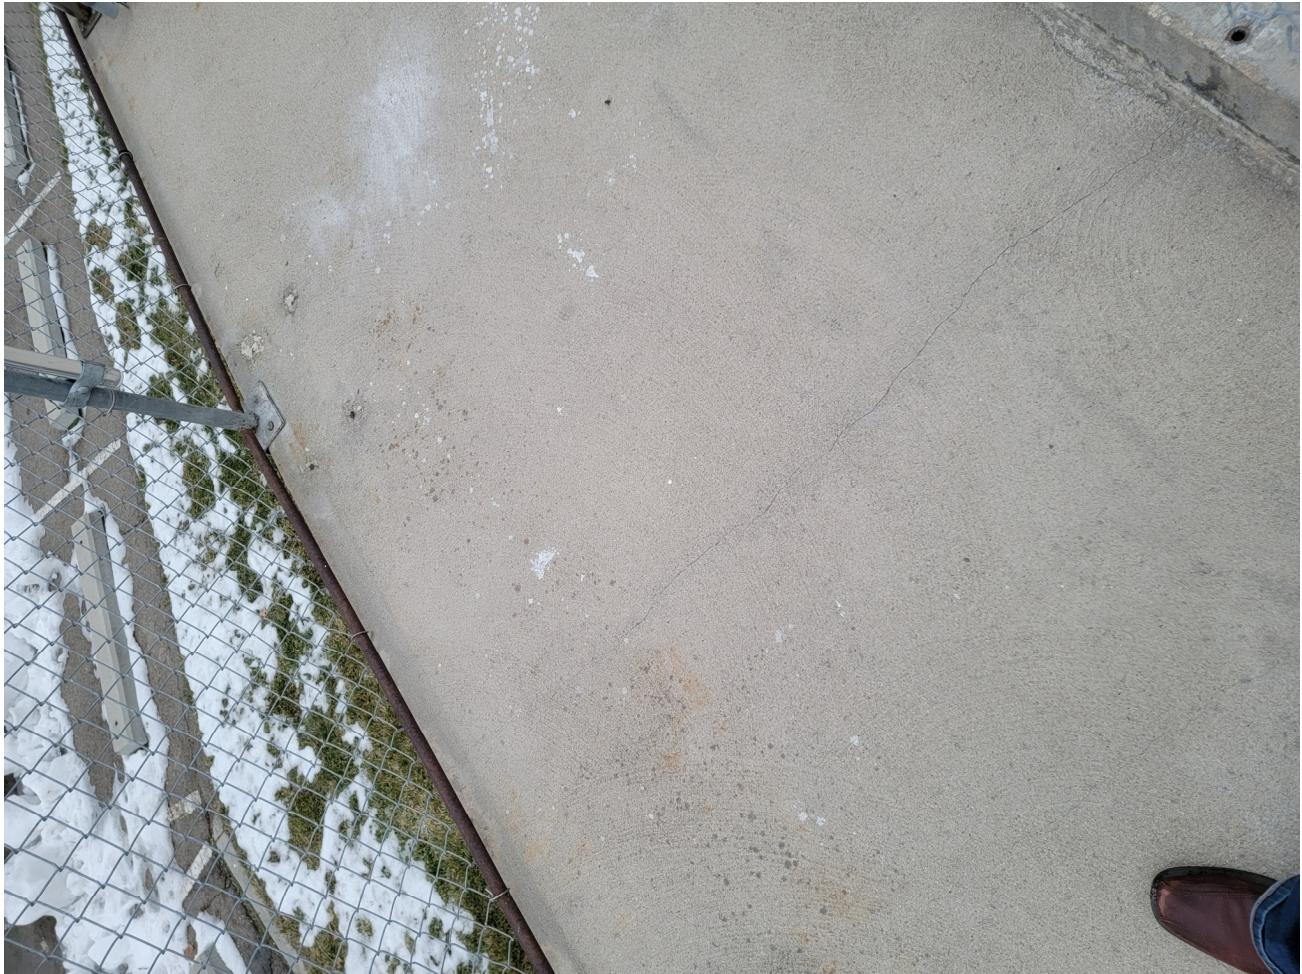
**Figure 5: Deck slab - Minor Topside Cracking**

- Interior/Exterior CMU walls – Seal observed cracks and recoat wall surfaces to prevent water intrusion into CMU walls.
- Pool Deck
  - At areas of significant deterioration, sawcut & remove any easily removable concrete around the damaged area. Extend cut 6'' beyond damaged area to competent concrete and replace with new repair mortar.
  - Cut & remove all exposed and corroded rebar
  - Install new rebar matching cut rebar; overlap or weld to existing rebar
  - Remove dust & wash surface with water to achieve a dry surface afterwards
  - Patch damaged area with repair mortar.
  - Seal exposed concrete surfaces to minimize water intrusion into concrete and protect rebar against corrosion.

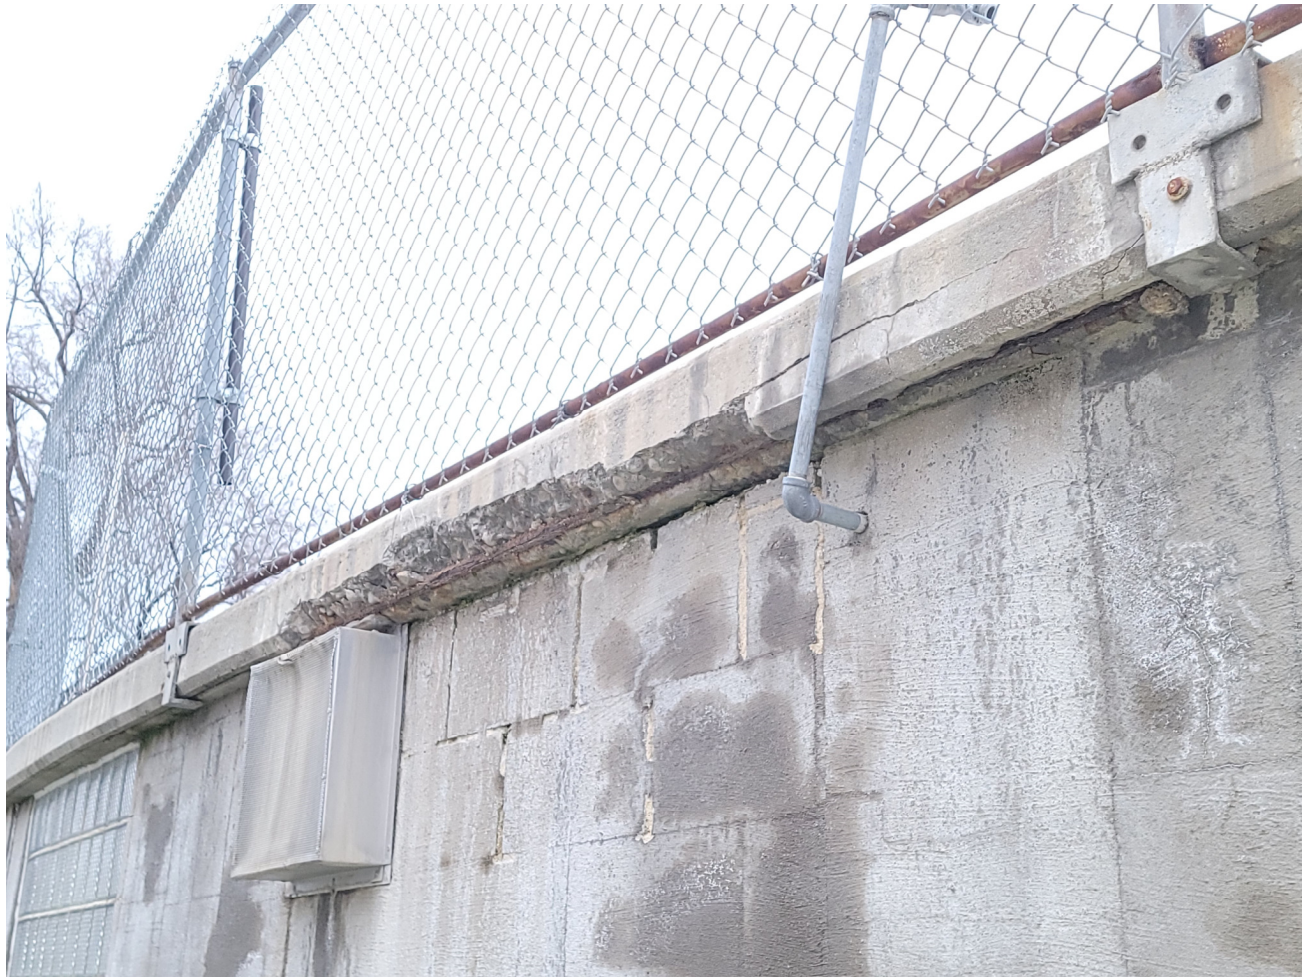
**Figure 6: Deck slab – Bottom of Deck Deterioration due to ASR/ Exposed Rebar**

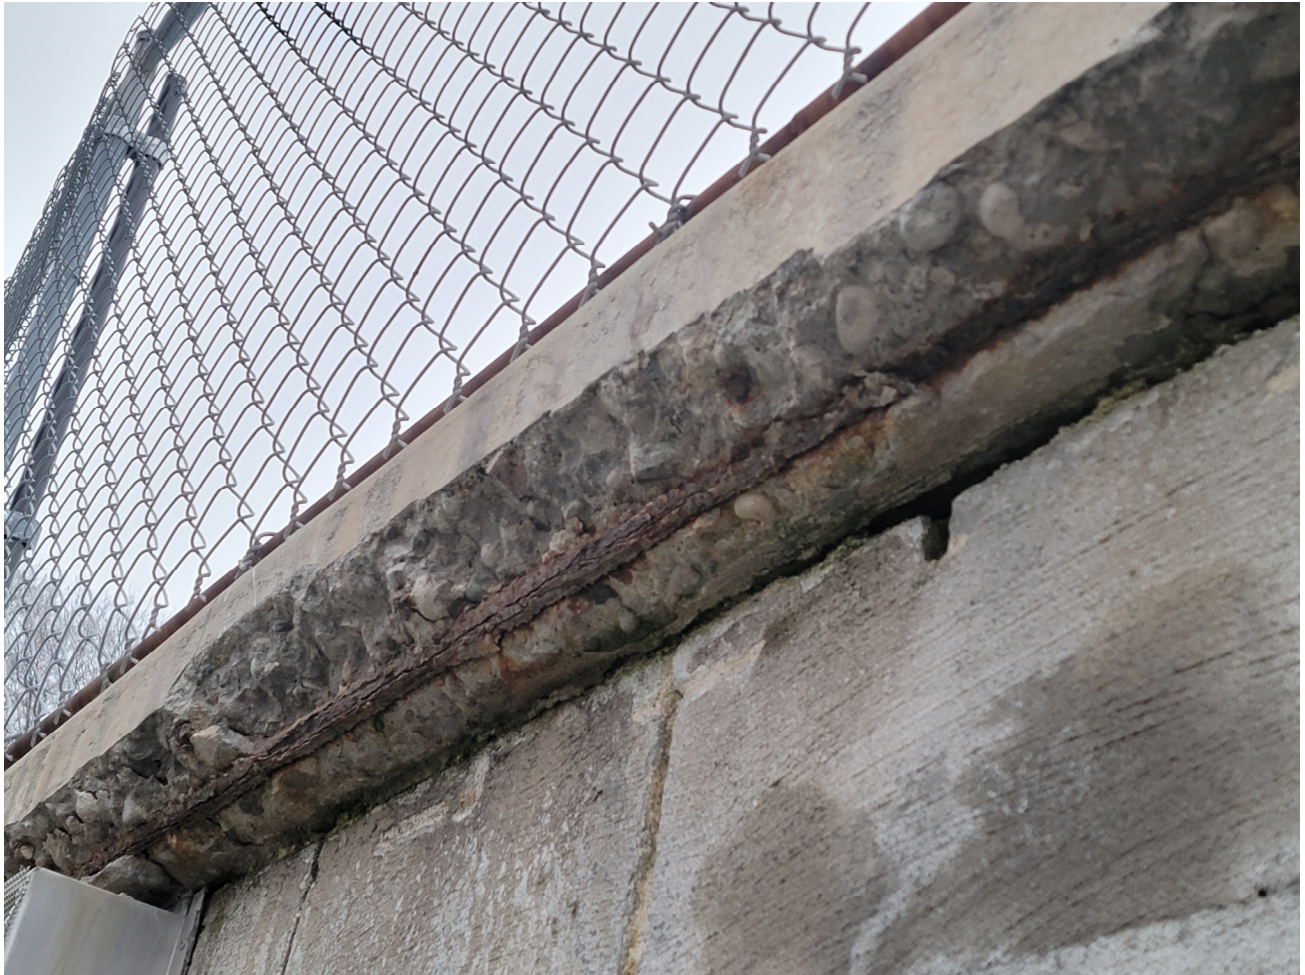
**Figure 7: Deck slab –Damaged Concrete / Exposed Rebar**

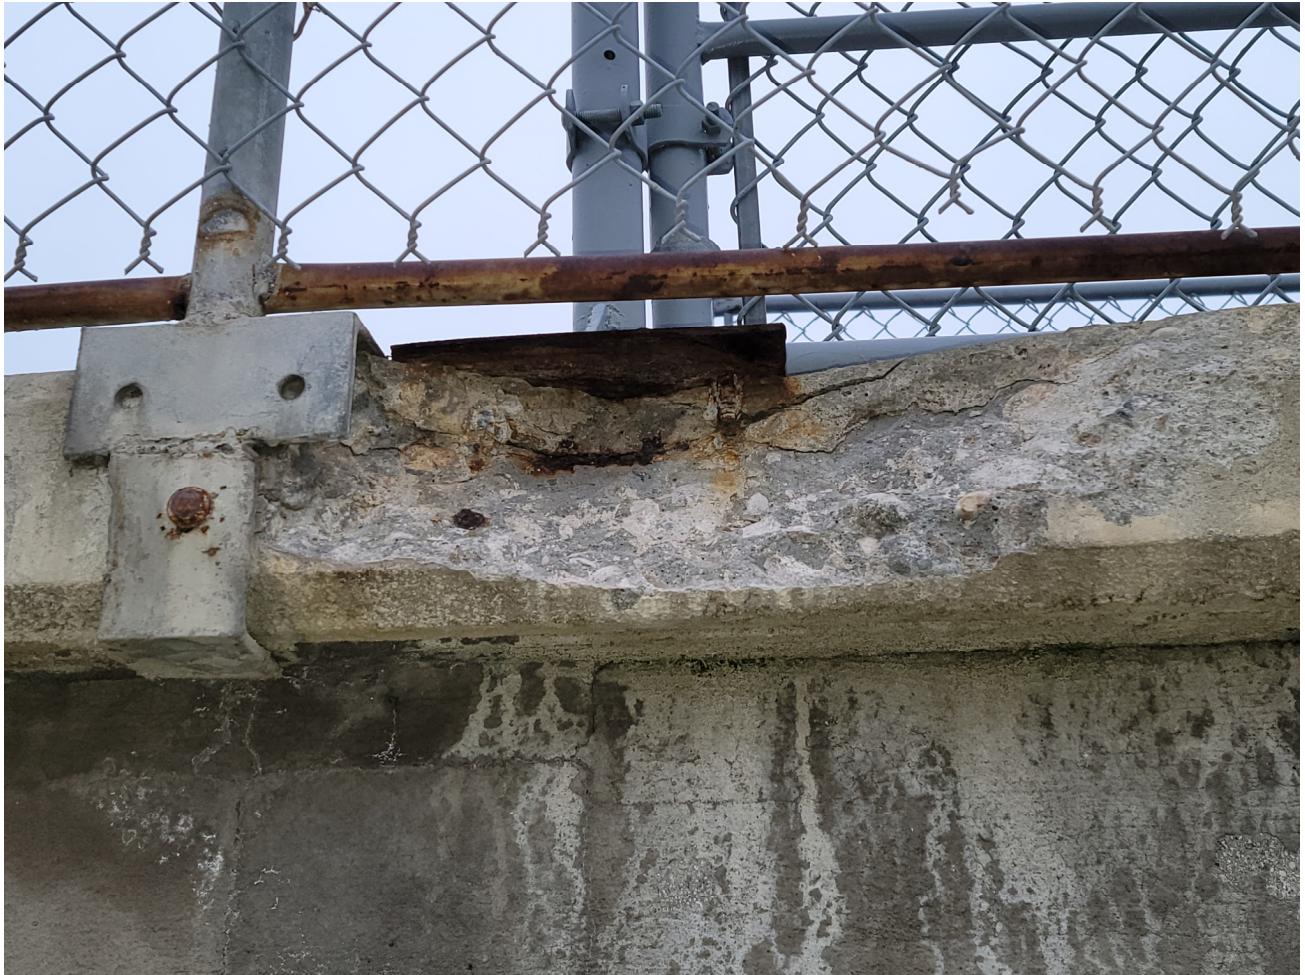
**Figure 8: Deck slab – ASR/Deck Spalling Under Fence Base Plate / Exposed Anchor**

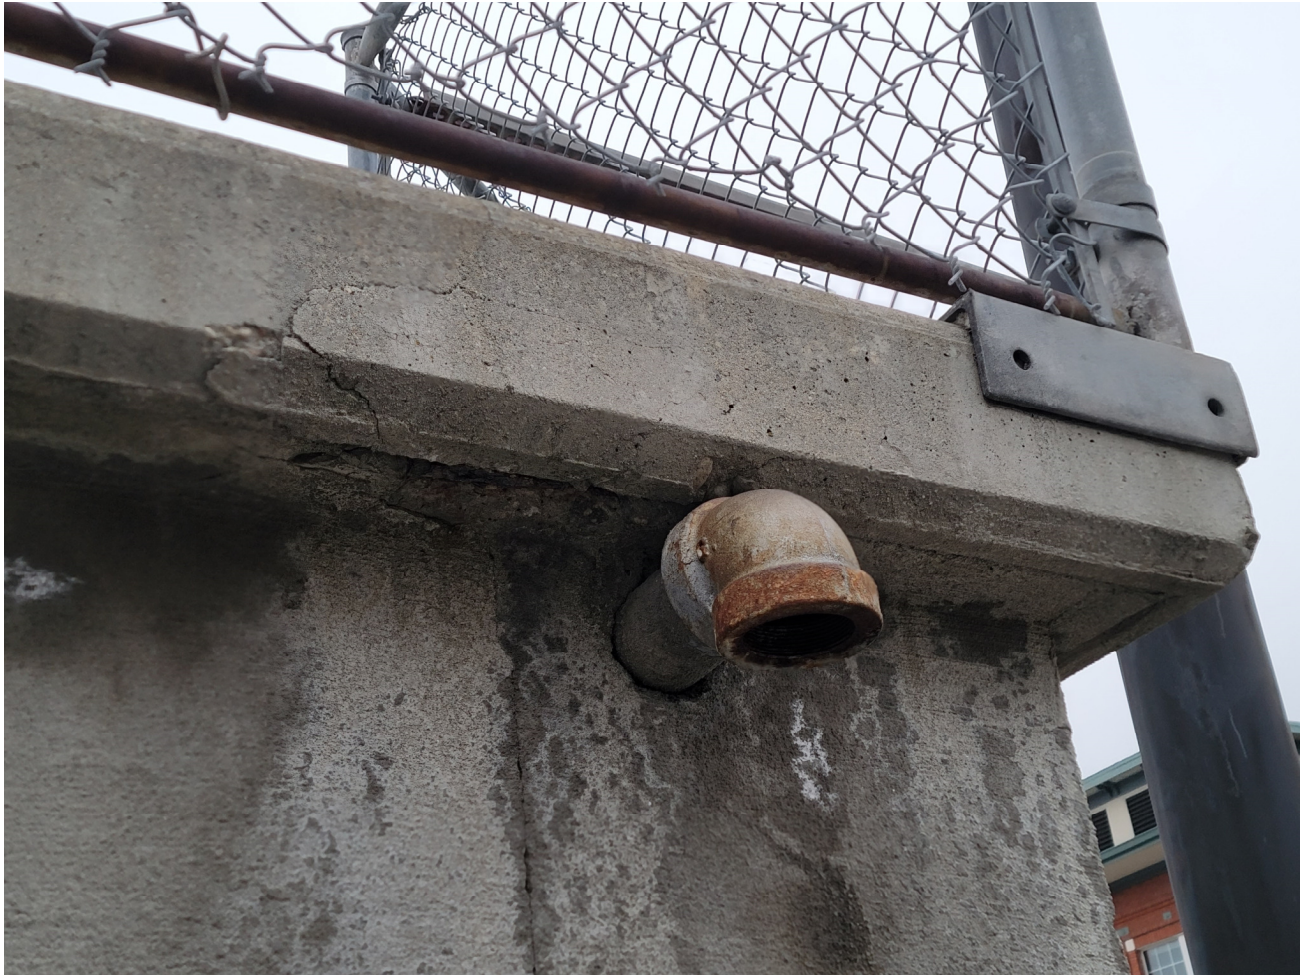
**Figure 9: Deck slab – Minor Cracking at Edge of Top Deck**

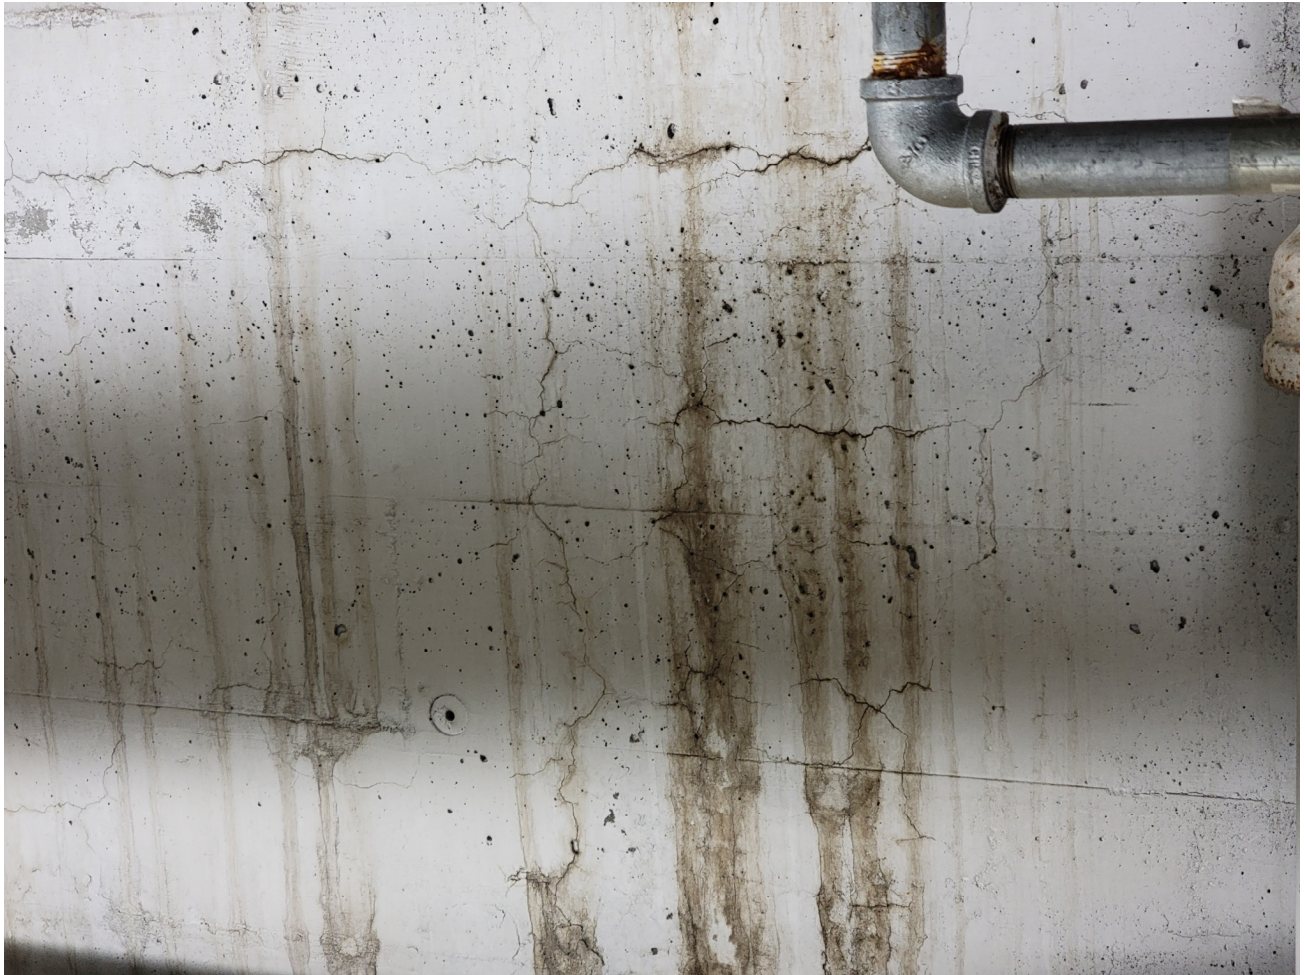
**Figure 10: Interior Pool Wall – Minor Cracking**

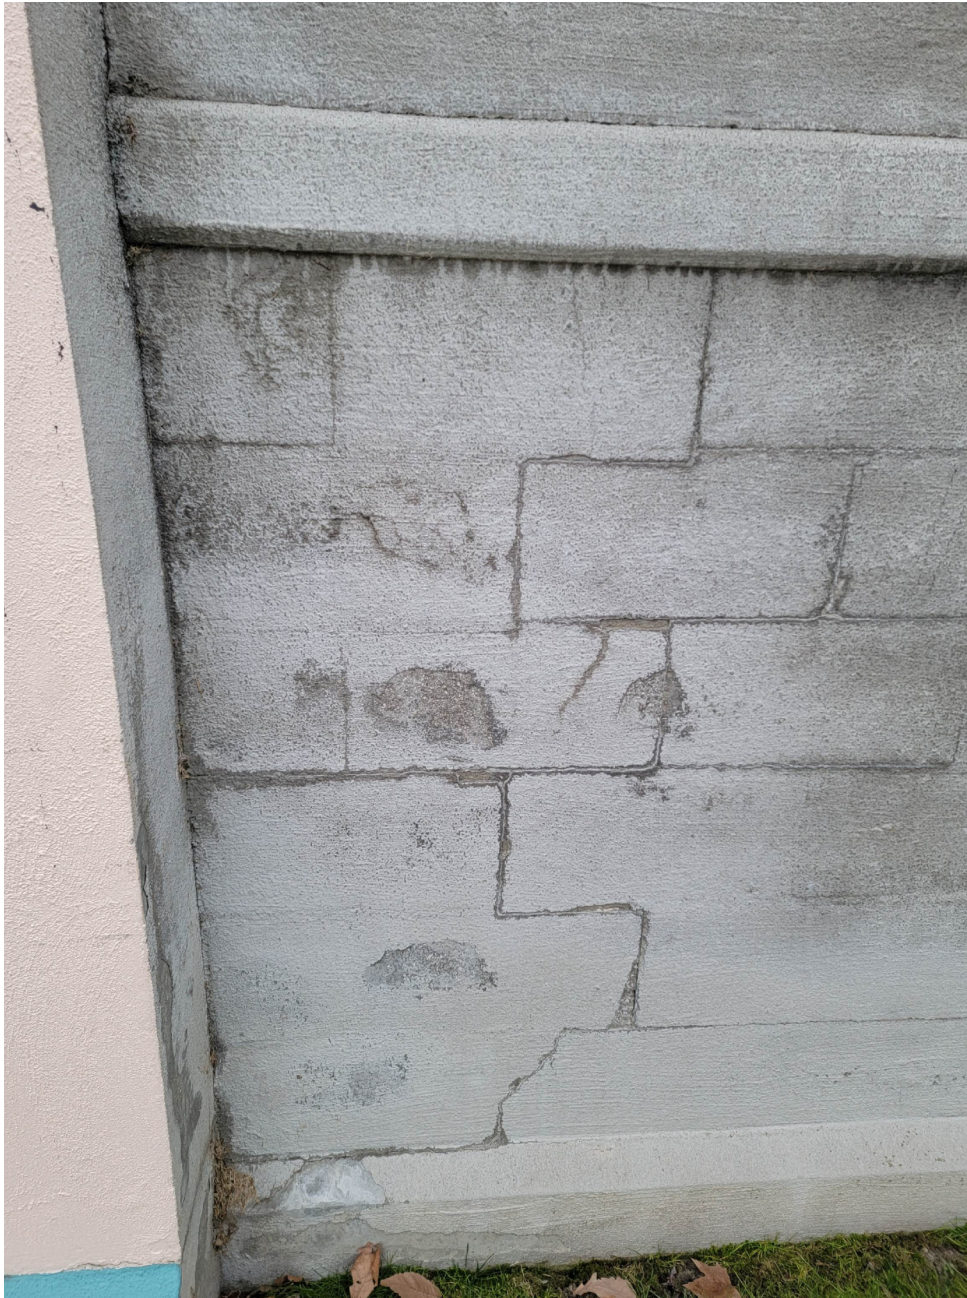
**Figure 11: Outer CMU Wall – Minor Cracking**
