City of Boise
ADA Assessment

Appendix A–Boise Urban Garden School

12/30/2020

Report #TO21-B011

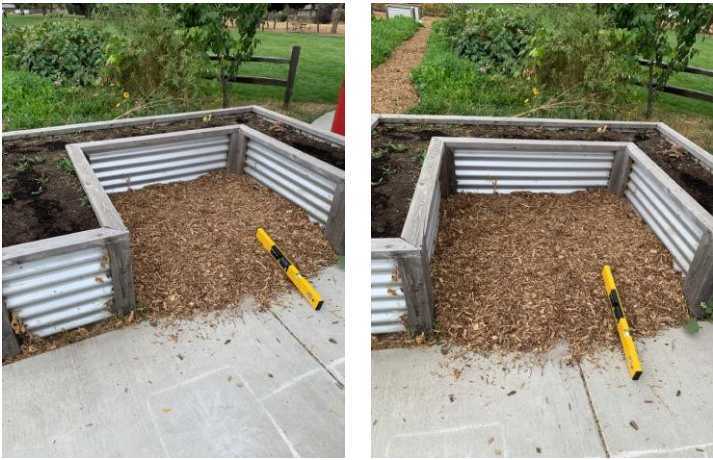
Location: Accessible Garden Plot
Schedule: 2021
Estimated Cost: \$500.00

2010 ADA Standards for Accessible Design Codes: §302.1, §305
There is not a firm, stable, and slip resistant route to the accessible garden plot. Currently, the plot has a 12.2% running slope.

Remove the excessive mulch and replace it with Engineered Wood Fiber so that the running and cross slopes do not exceed 2%.

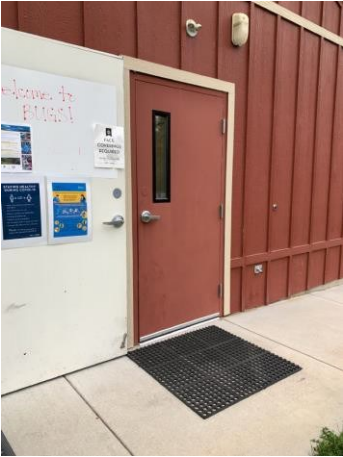
Location: Barn
Schedule: 2021
Estimated Cost: \$100.00

2010 ADA Standards for Accessible Design Codes: §216.2, §703
There is no tactile sign identifying the permanent room.

Install tactile signage on the latch side of the doorway at a height of 48" minimum to 60" maximum above the floor, identifying room by name or room number.
Signs shall be Braille with raised lettering and should be placed on the wall in the center of an 18"x18" clear floor space.

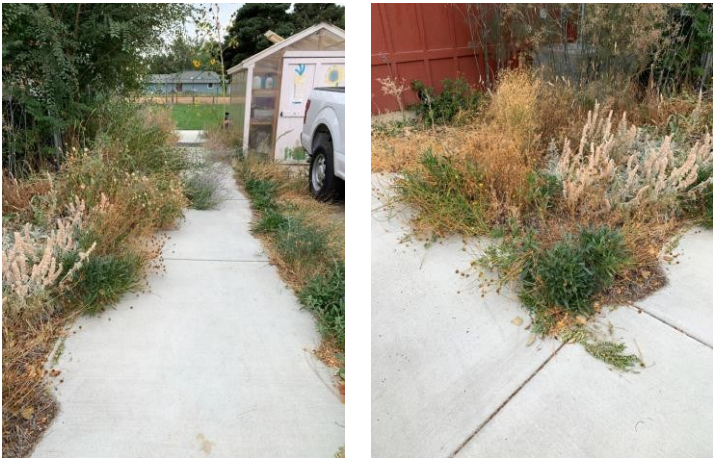
Location: Barn
Schedule: 2021
Estimated Cost: \$100.00

2010 ADA Standards for Accessible Design Codes: §403.5.1
Due to the foliage, there is not a clear 36" width for wheelchairs to pass.

Trim and continue to maintain the foliage as to keep it out of the accessible route.

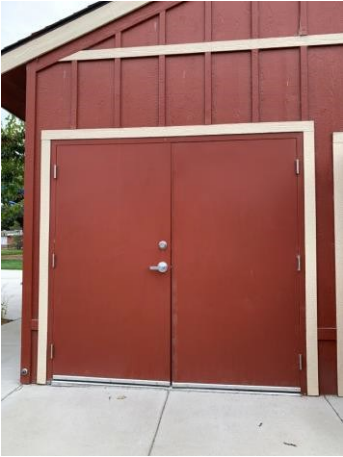
Location: Barn
Schedule: 2021
Estimated Cost: \$100.00

2010 ADA Standards for Accessible Design Codes: §216.2, §703
There is no tactile sign identifying the permanent room.

Install tactile signage on the latch side of the doorway at a height of 48” minimum to 60” maximum above the floor, identifying room by name or room number.
Signs shall be Braille with raised lettering and should be placed on the wall in the center of an 18"x18" clear floor space.

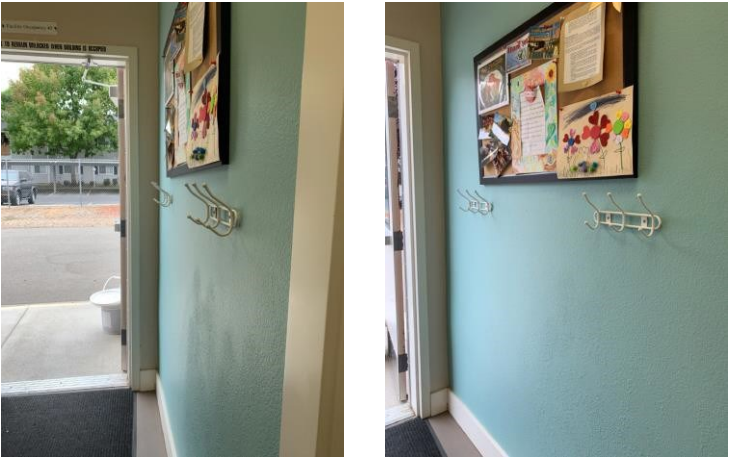
Location: Barn
Schedule: 2021
Estimated Cost: \$100.00

2010 ADA Standards for Accessible Design Codes: §308.2.1
The hooks are outside of the unobstructed forward reach range at 50.5" above the floor.

Lower the hooks by 2.5" to meet the accessible reach range of 48" maximum above the floor.

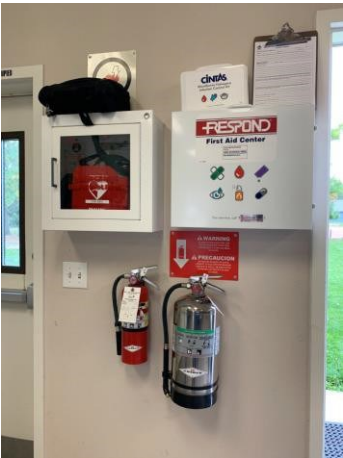
Location: Barn
Schedule: 2021
Estimated Cost: \$100.00

2010 ADA Standards for Accessible Design Codes: §307.2
The silver fire extinguisher protrudes 7" into the circulation space at 29.25" above the floor.

Recess the silver fire extinguisher so it protrudes a maximum of 4", lower it so the bottom edge is 27" maximum above the floor, or place a cane detectable object beneath it.

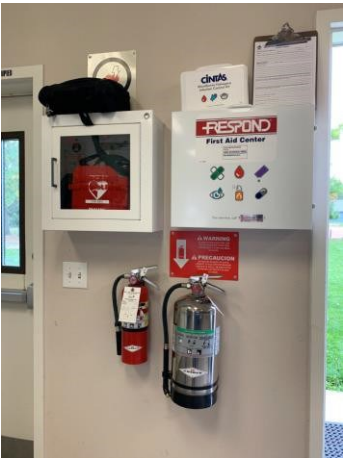
Location: Barn
Schedule: 2021
Estimated Cost: \$100.00

2010 ADA Standards for Accessible Design Codes: §307.2
The red fire extinguisher protrudes 4.25" into the circulation space at 33.5" above the floor.

Recess the red fire extinguisher so it protrudes a maximum of 4", lower it so the bottom edge is 27" maximum above the floor, or place a cane detectable object beneath it.

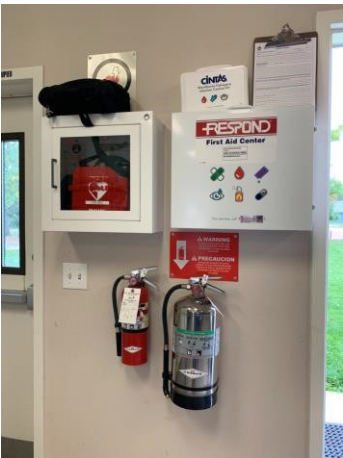
Location: Barn
Schedule: 2021
Estimated Cost: \$100.00

2010 ADA Standards for Accessible Design Codes: §308.2.1, §307.2
 The first aid box protrudes 5.5" into the circulation space at 54.75" above the floor.
 The first aid box is outside of the unobstructed forward reach range at 54.75" above the floor.

Recess the first aid box so it protrudes a maximum of 4", lower it so the bottom edge is 27" maximum above the floor, or place a cane detectable object beneath it.
 Lower the first aid box by 6.75" to meet the accessible reach range of 15" minimum and 48" maximum above the floor.

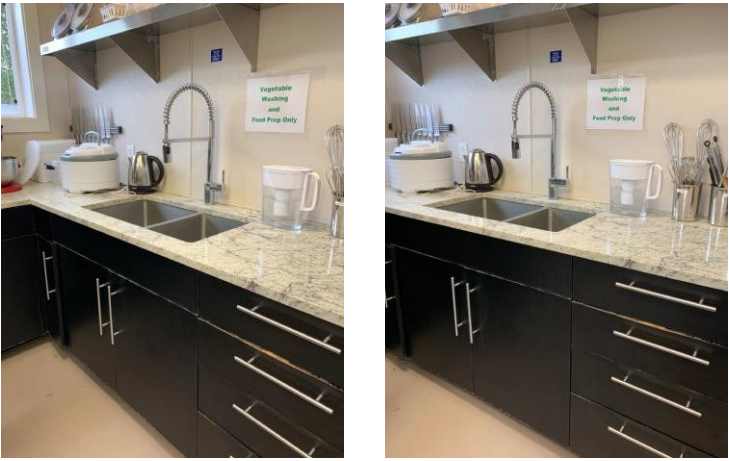
Location: Barn
Schedule: 2023
Estimated Cost: \$1,000.00

2010 ADA Standards for Accessible Design Codes: §902.3, §306.3.3
There is no knee clearance underneath the sink.
The sink and work surface counter is 36" above the floor.

Provide knee clearance underneath the counter at the sink that is a minimum of 11" deep at 9" above the floor and 8" deep at 27" above the floor.
A 30" portion of the work surface must be no higher than 34" above the floor. Lower the sink to the maximum height of 34" above the floor.

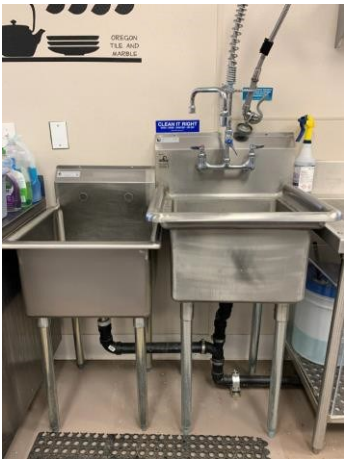
Location: Barn
Schedule: 2022
Estimated Cost: \$1,000.00

2010 ADA Standards for Accessible Design Codes: §606.3
The sink is 39" above the floor.

Lower the sink to a maximum height of 34" above the floor. Please note that this sink does not accommodate knee clearance. Consider adding another accessible sink nearby.

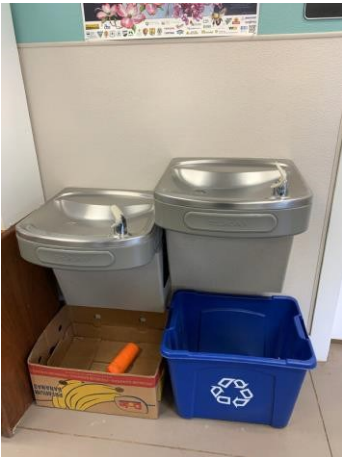
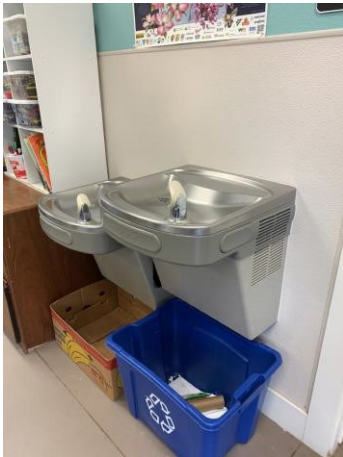
Location: Barn
Schedule: 2022
Estimated Cost: \$1,000.00

2010 ADA Standards for Accessible Design Codes: §602.4, §602.7
The spout heights of the drinking fountains are not compliant at 31.5" and 37" above the floor.

Raise the existing tall drinking fountain in order to comply with the 38" minimum to 43" maximum spout height above the floor.

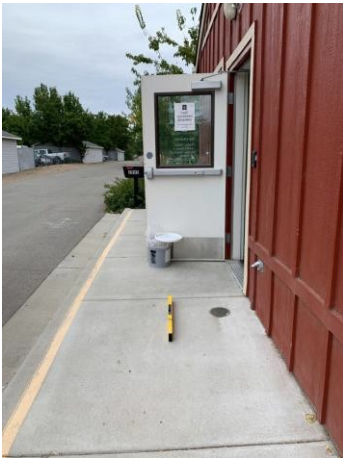
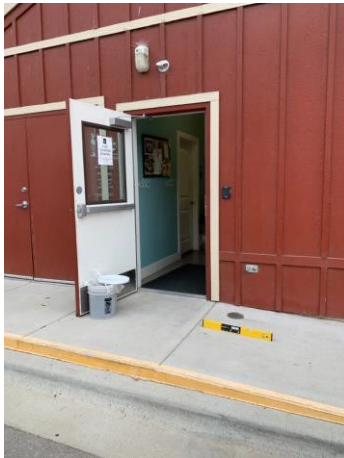
Location: Barn
Schedule: 2021
Estimated Cost: \$2,000.00

2010 ADA Standards for Accessible Design Codes: §404.2.4.1
There is not adequate maneuvering clearance to operate the door. The maneuvering clearance to operate the door has a 5.3% slope.

Reconstruct the sidewalk to ensure that the maneuvering clearance extends 24" to the latch side of the door and has a maximum slope of 2% in all directions.

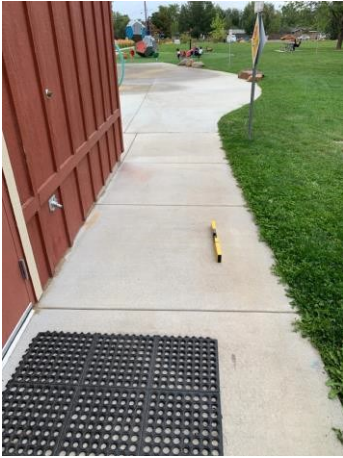
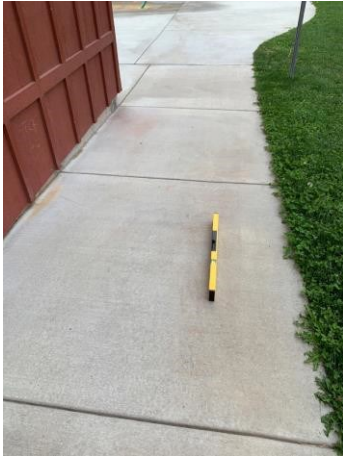
Location: Barn
Schedule: 2021
Estimated Cost: \$2,500.00

2010 ADA Standards for Accessible Design Codes: §403.3
The running slope is 5.8%.

Either reconstruct the sidewalk to have a maximum running slope of 5% or add handrails on either side.

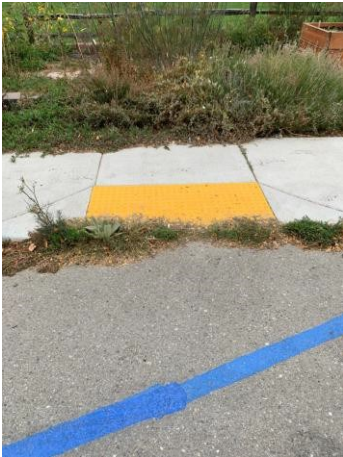
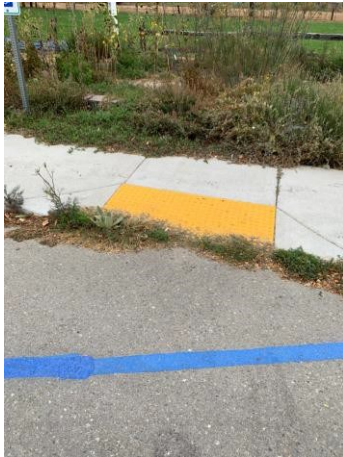
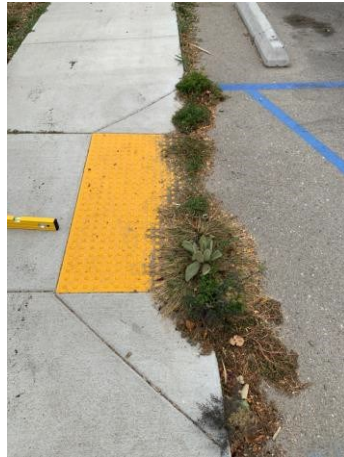
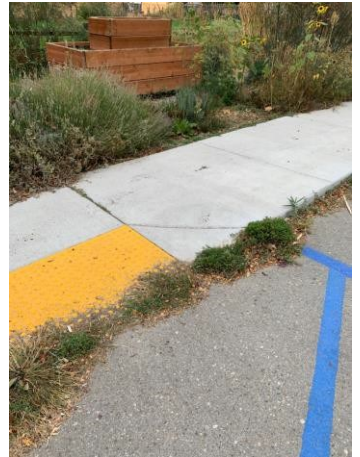
Location: Barn Parking

The weeds at the access aisle are causing a change in level posing a tripping hazard for users.

Remove the weeds.

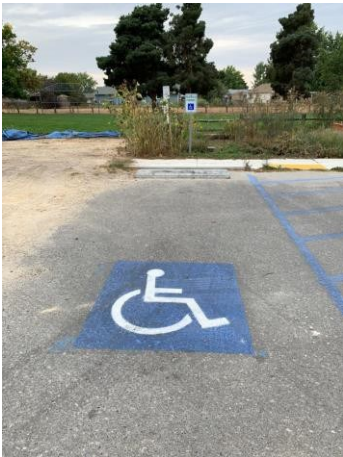
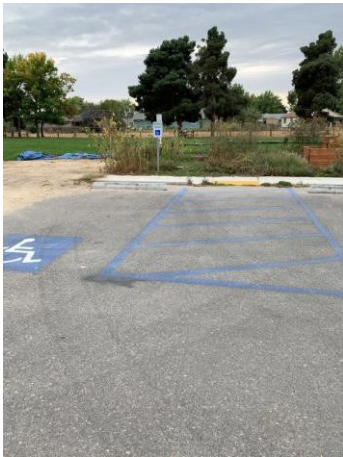
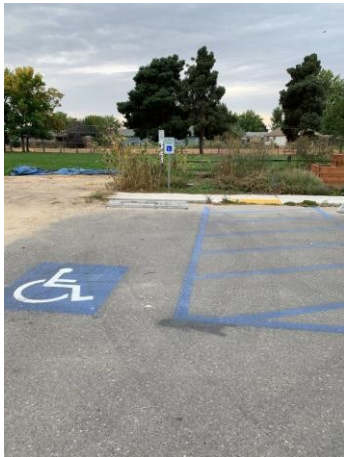
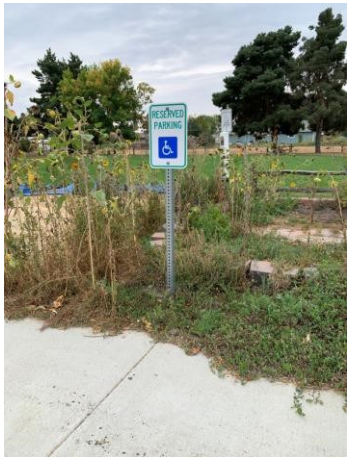
Location: Barn Parking
Schedule: 2021
Estimated Cost: \$100.00

2010 ADA Standards for Accessible Design Codes: §208.2.4
 There are no marked "Van Accessible" spaces.

Add a "van accessible" parking sign at a minimum height of 60" above the ground.

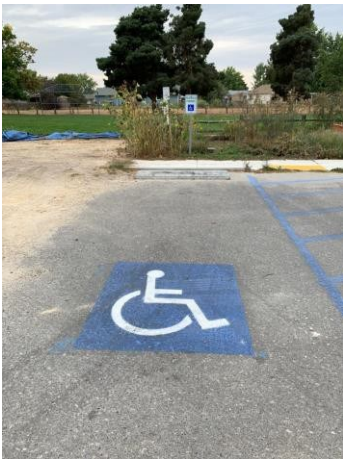
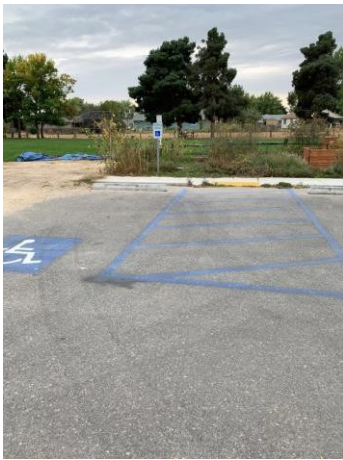
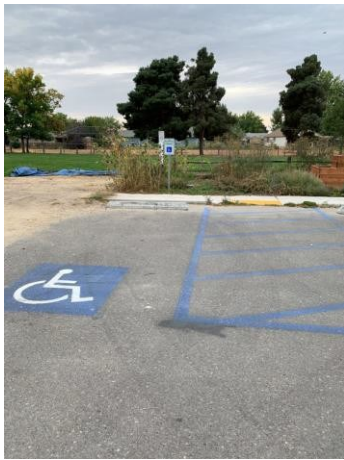
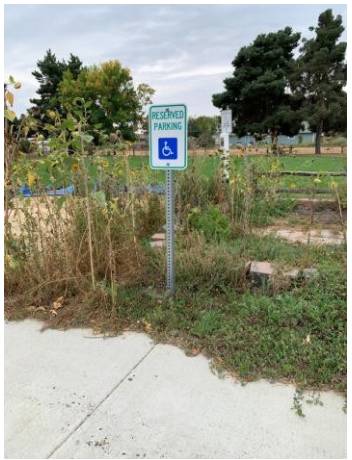
Location: Barn Parking
Schedule: 2021
Estimated Cost: \$100.00

2010 ADA Standards for Accessible Design Codes: §216.5
 The parking sign identifying the accessible parking space does not meet the minimum height requirement of 60" from the ground at 43.5" above the ground.

Remount the accessible parking sign to ensure 60" minimum height from the ground.

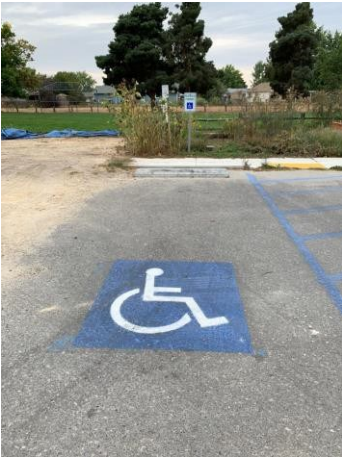
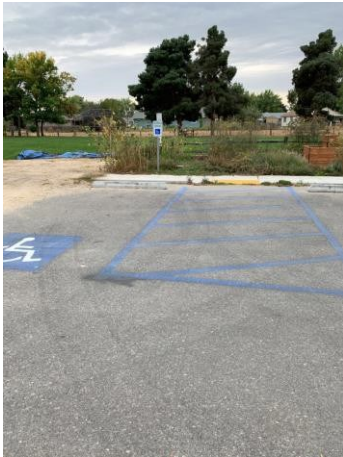
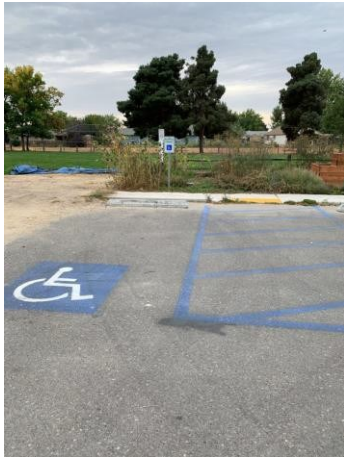
Location: Barn Parking
Schedule: 2023
Estimated Cost: \$1,000.00

2010 ADA Standards for Accessible Design Codes: §502
There is no painted line on the left side of the accessible parking space.

Restripe the accessible parking space.

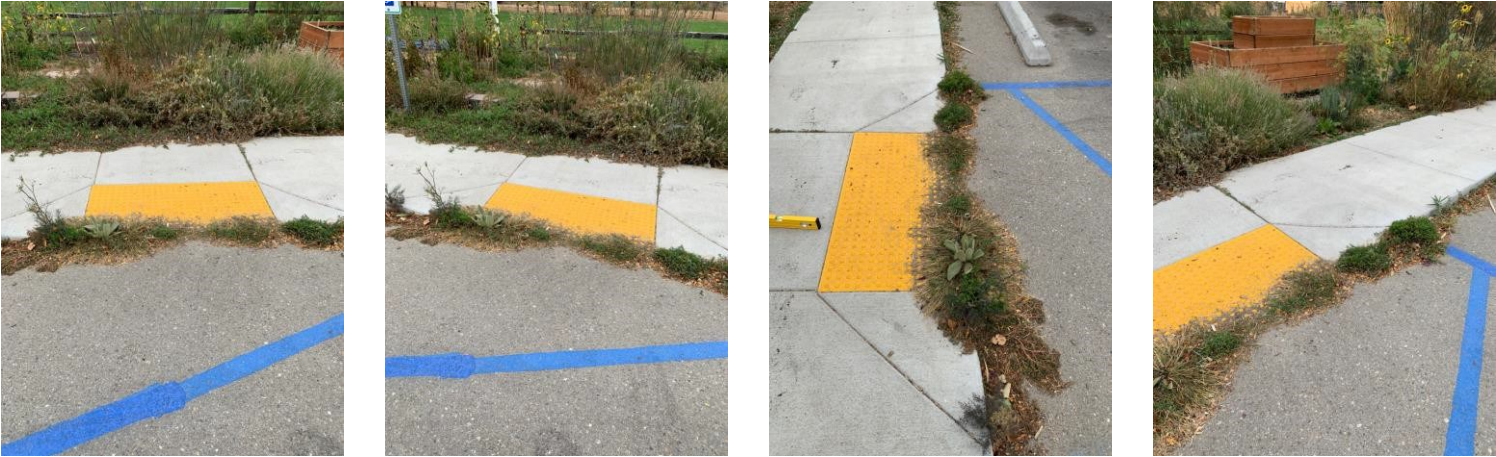
Location: Barn Parking
Schedule: 2021
Estimated Cost: \$2,500.00

2010 ADA Standards for Accessible Design Codes: §406.4, §406.3
The curb ramp flares have a 10.9% slope.
There is no landing provided at the top of the curb ramp.

Resurface the curb ramp flares to ensure a maximum slope of 10%.
Create a parallel curb ramp to allow for a wheelchair user to turn within the ramp to go left or right out of the detectable warning area.

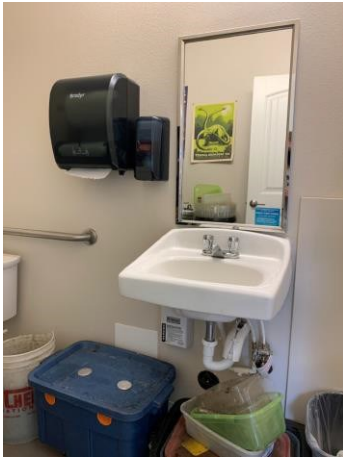
Location: Barn Restroom
Schedule: 2021
Estimated Cost: \$100.00

2010 ADA Standards for Accessible Design Codes: §606.5
The pipes under the sink are not covered.

Wrap the pipes beneath the sink with soft protective wrap or plastic.

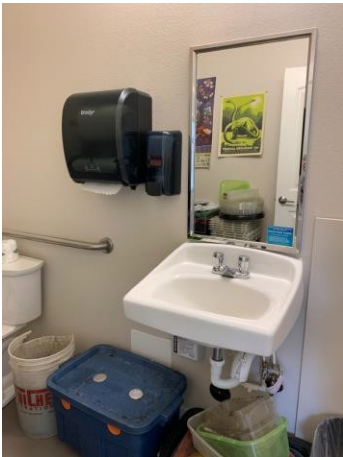
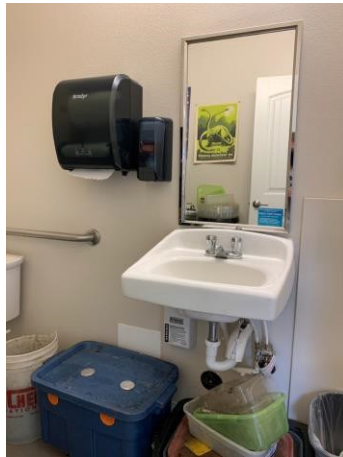
Location: Barn Restroom

The paper towel dispenser is outside of the unobstructed forward reach range at 49" above the floor.

Lower the paper towel dispenser by 1" to meet the accessible reach range of 48" maximum above the floor.

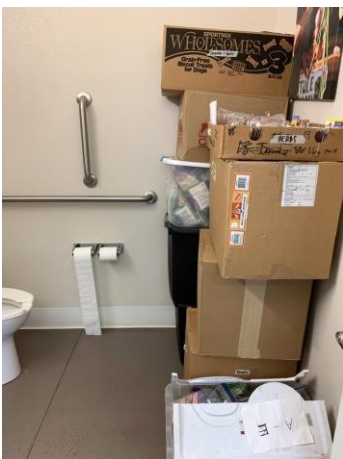
Location: Barn Restroom
Schedule: 2021
Estimated Cost: \$100.00

2010 ADA Standards for Accessible Design Codes: §604.3.1
The clearance around the water closet is less than 60"x56" when measured perpendicular from the side wall and rear wall due to the stored items.

Remove the boxes and other stored items from the restroom.

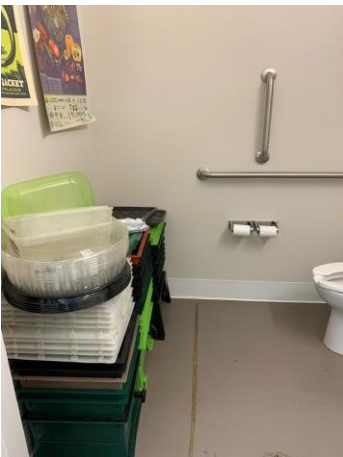
Location: Barn Restroom
Schedule: 2021
Estimated Cost: \$100.00

2010 ADA Standards for Accessible Design Codes: §604.3.1
The clearance around the water closet is less than 60"x56" when measured perpendicular from the side wall and rear wall due to the stored items.

Remove the stored items from the restroom.

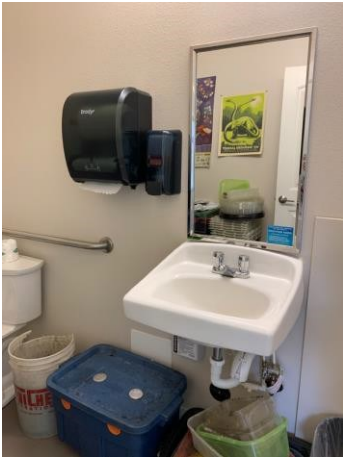
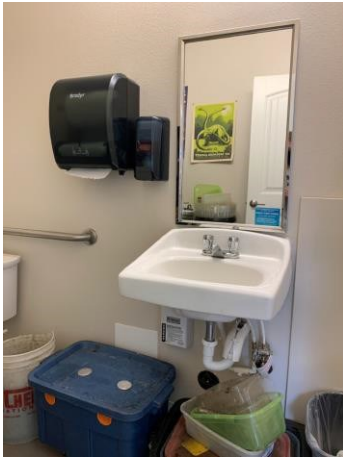
Location: Barn Restroom
Schedule: 2022
Estimated Cost: \$1,000.00

2010 ADA Standards for Accessible Design Codes: §606.3
The sink is 35" above the floor.

Lower the sink to a maximum height of 34" above the floor.

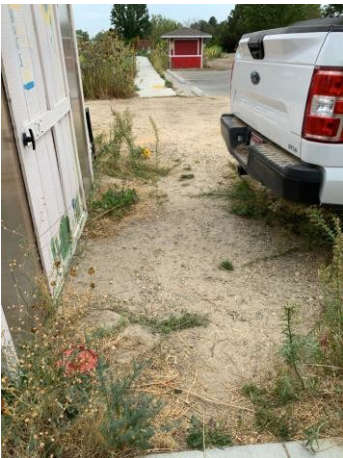
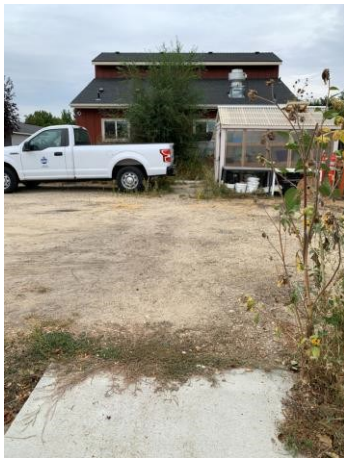
Location: Barn to Garden
Schedule: 2021
Estimated Cost: \$10,000.00

2010 ADA Standards for Accessible Design Codes: §302.1, §305
There is not a firm, stable, and slip resistant route to the garden from the barn.

Construct a firm, stable, and slip resistant accessible route with a maximum cross slope of 2% and maximum running slope of 5%.

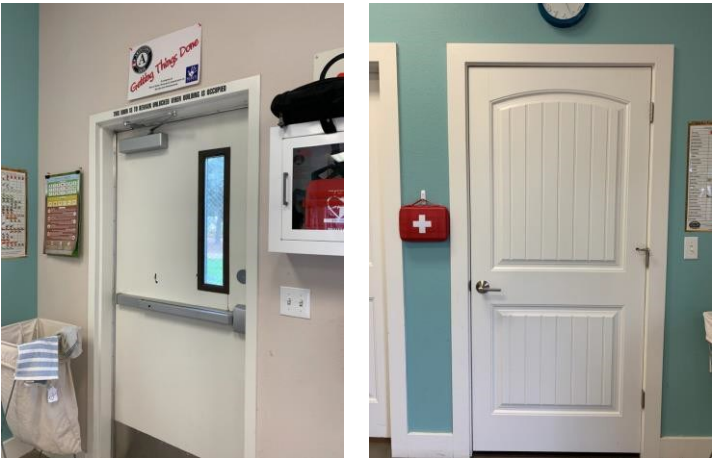
Location: Entire Facility
Schedule: 2021
Estimated Cost: \$800.00

2010 ADA Standards for Accessible Design Codes: §216.2, §703
There are no tactile signs identifying eight permanent rooms.

Install tactile signage on the latch side of the doorway at a height of 48” minimum to 60” maximum above the floor, identifying room by name or room number. Signs shall be Braille with raised lettering and should be placed on the wall in the center of an 18"x18" clear floor space.

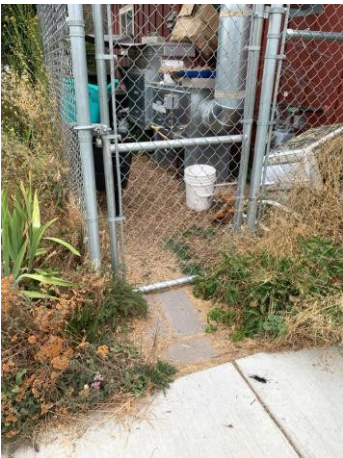
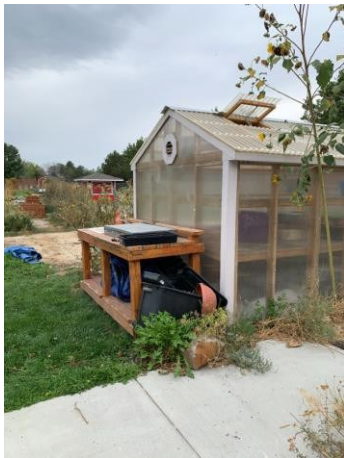
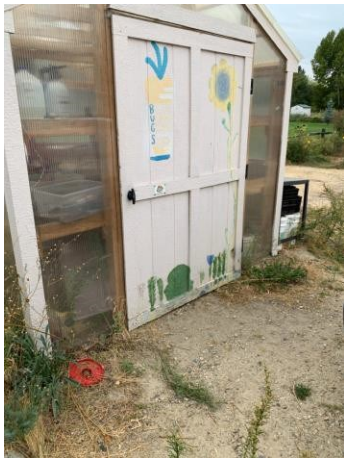
Location: Garden
Schedule: 2021
Estimated Cost: \$5,000.00

2010 ADA Standards for Accessible Design Codes: §302.1, §305
There is not a firm, stable, and slip resistant route to the green house.

Construct a firm, stable, and slip resistant accessible route with a maximum cross slope of 2% and maximum running slope of 5%.

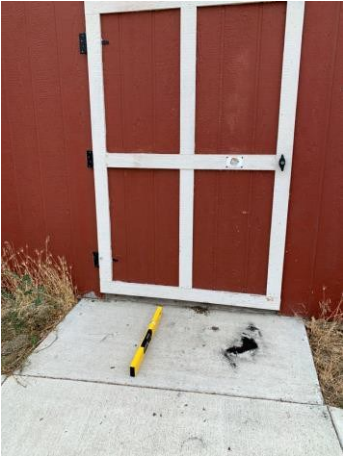
Location: Garden Barn
Schedule: 2021
Estimated Cost: \$2,500.00

2010 ADA Standards for Accessible Design Codes: §404.2.4.4
The barn entrance has an 8.3% slope.

Reconstruct the entryway to reduce the running slope to a maximum of 2% in all directions.

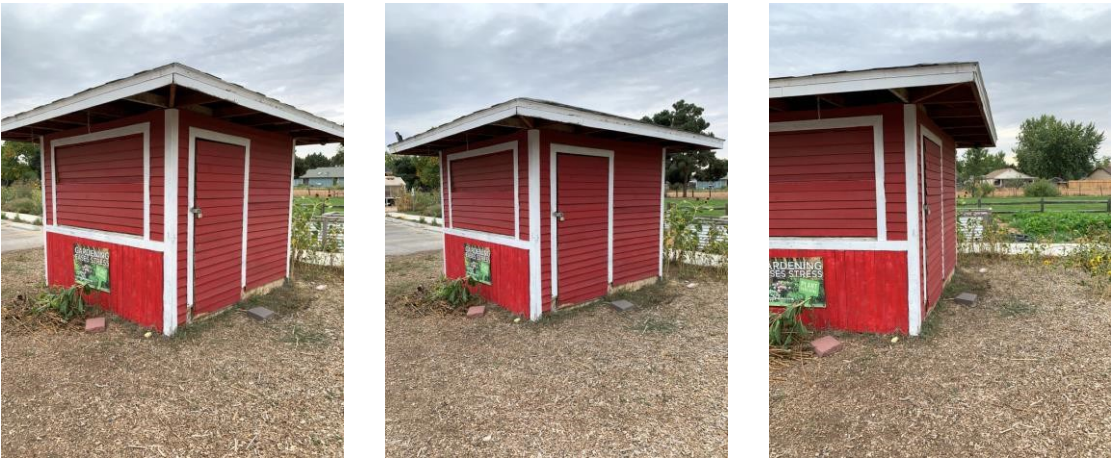
Location: Garden Barn
Schedule: 2021
Estimated Cost: \$5,000.00

2010 ADA Standards for Accessible Design Codes: §302.1, §305
There is not a firm, stable, and slip resistant route to the garden barn used by volunteers and staff.

Construct a firm, stable, and slip resistant accessible route with a maximum cross slope of 2% and maximum running slope of 5%. Or remove the excessive mulch and replace it with Engineered Wood Fiber so that the running and cross slopes do not exceed 2%.

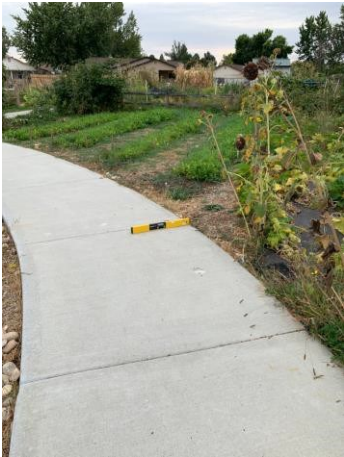
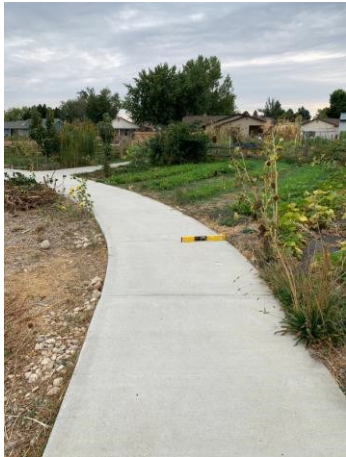
Location: Garden By the Bees
Schedule: 2021
Estimated Cost: \$1,000.00

2010 ADA Standards for Accessible Design Codes: §403.3
 The cross slope is 2.4%.

Resurface the route to reduce the cross slope to a maximum of 2%.

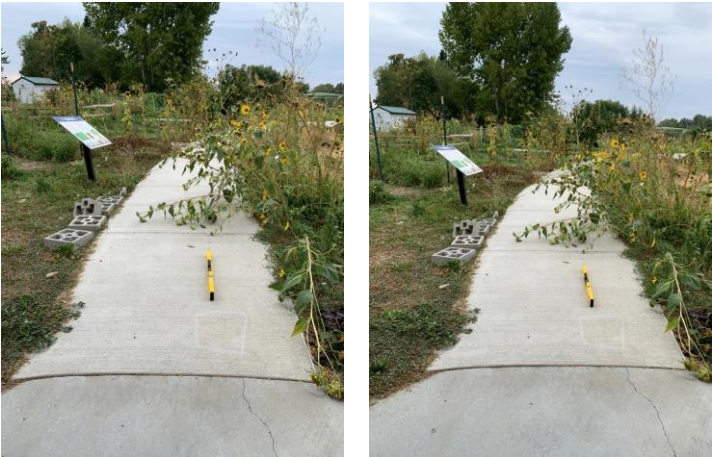
Location: Garden From Gazebo to Pollinators
Schedule: 2021
Estimated Cost: \$2,500.00

2010 ADA Standards for Accessible Design Codes: §403.3
The running slope of the route from the gazebo to the pollinators ranges from 5.5% to 6.3%.

Resurface the route to reduce the running slope to a maximum of 5%.

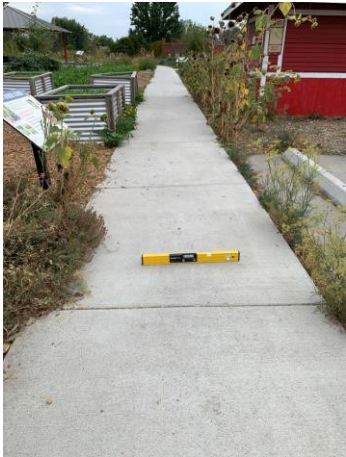
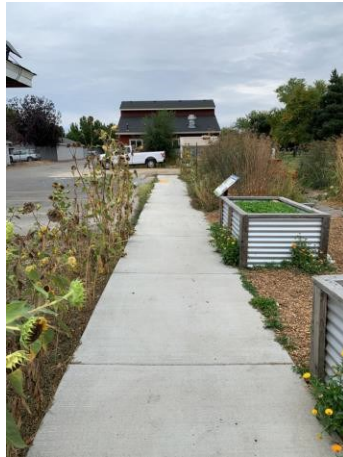
Location: Garden From Standing Plots To Barn

The cross slope is 4.5%.

Reconstruct the route to reduce the cross slope to a maximum of 2%.

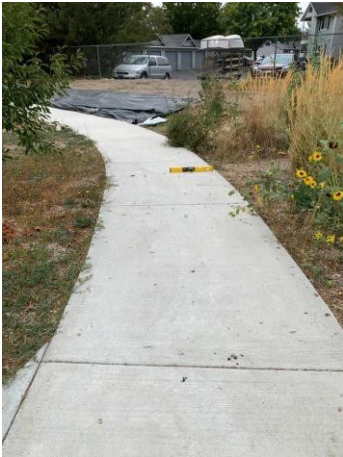
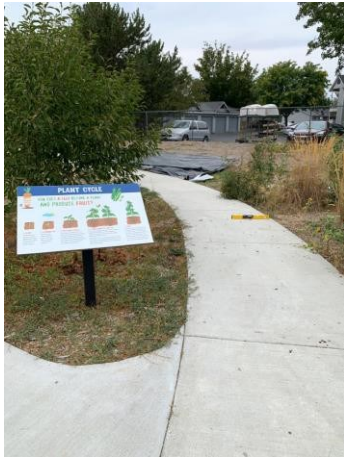
Location: Garden Next to Plant Cycle
Schedule: 2021
Estimated Cost: \$1,000.00

2010 ADA Standards for Accessible Design Codes: §403.3
The cross slope is 2.6%.

Resurface the route to reduce the cross slope to a maximum of 2%.

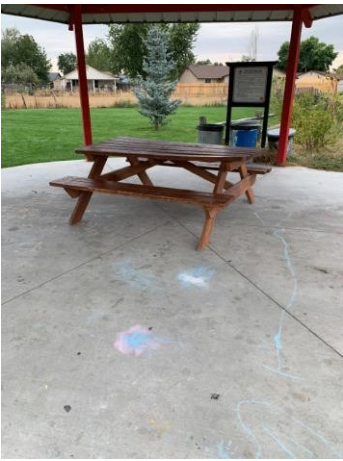
Location: Garden Picnic Table
Schedule: 2021
Estimated Cost: \$1,000.00

2010 ADA Standards for Accessible Design Codes: §226.1, §902, §305, §306
The provided picnic table does not have an accessible clear space for a wheelchair user.

Add/replace picnic tables so that at least 5% of the seating is wheelchair accessible.
Ensure that the wheelchair accessible seating has a clear floor space of 30" x 48" with a slope not steeper than 2% and that the tables have sufficient knee and toe clearance.
