City of Boise ADA Assessment

# Appendix A - Fort Boise Community Center

1/8/2021

Report #TO20-B012

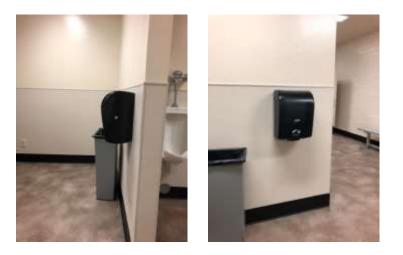
#### **2010 ADA Standards for Accessible Design Codes:** §307.2

The paper towel dispenser protrudes 9" into the circulation space at 33" above the floor.

Recess the paper towel dispenser so it protrudes a maximum of 4" or place a cane detectable object beneath it.

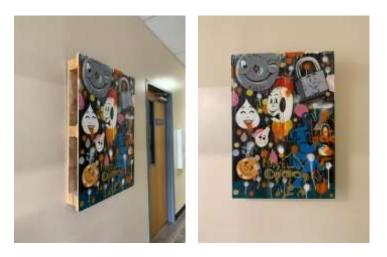
#### PHOTOGRAPH(S) OF THIS LOCATION

**2010 ADA Standards for Accessible Design Codes:** §307.2

The art protrudes 5.25" into the circulation space at 39.5" above the floor.

Recess the art so it protrudes a maximum of 4", lower it so the bottom edge is 27" maximum above the floor, or place a cane detectable object beneath it.

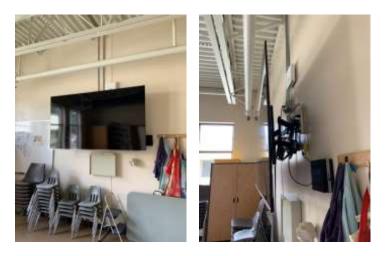
**2010 ADA Standards for Accessible Design Codes:** §307.2

The TV protrudes 13" into the circulation space at 57" above the floor.

Recess the TV so it protrudes a maximum of 4", raise it so the bottom edge is 80" maximum above the floor, or place a cane detectable object beneath it.

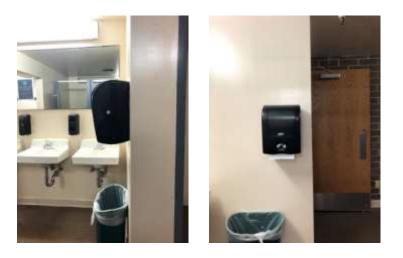
#### **2010 ADA Standards for Accessible Design Codes:** §307.2

The paper towel dispenser protrudes 9" into the circulation space at 44" above the floor.

Recess the paper towel dispenser so it protrudes a maximum of 4" or place a cane detectable object beneath it.

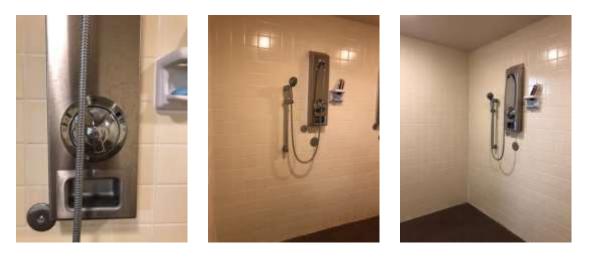
2010 ADA Standards for Accessible Design Codes: §608.5.1

The shower controls are 54" above the floor.

Adjust the height of shower controls to a minimum height of 38" and a maximum height of 48" above the floor.

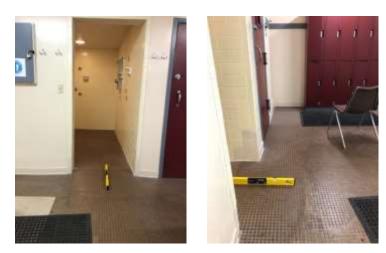
2010 ADA Standards for Accessible Design Codes: §403.3

The running slope to the showers is 5.4%.

Reconstruct the route to ensure the slope is a maximum of 2% outside of the shower's threshold.

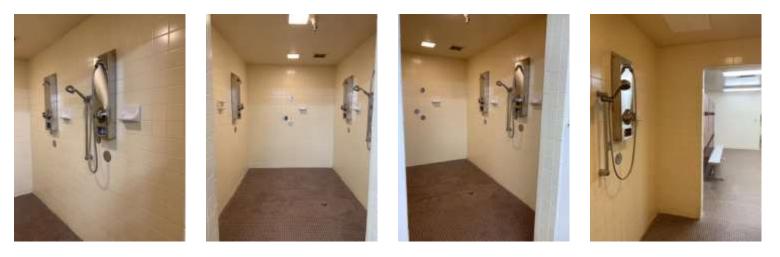
2010 ADA Standards for Accessible Design Codes: §608.5.1

The shower controls are 56" above the floor.

Adjust the height of shower controls to a minimum height of 38" and a maximum height of 48" above the floor.

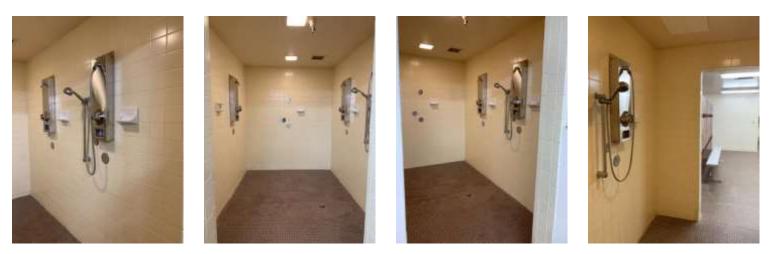
2010 ADA Standards for Accessible Design Codes: §607.6

The shower head is installed at 61" above the floor.

Install a secondary shower head with a 59" long minimum hose to allow for a user to sit or stand that is a maximum of 48" above the floor.

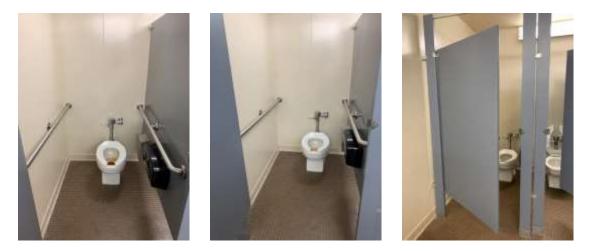
#### 2010 ADA Standards for Accessible Design Codes: §609.4

The ambulatory stall restroom side and rear grab bars are installed at 32.5" above the floor.

As a temporary fix until which time when a wheelchair accessible stall is installed, raise the side and rear grab bars to a minimum height of 33" and 36" maximum above the floor measured to the top of gripping surface.

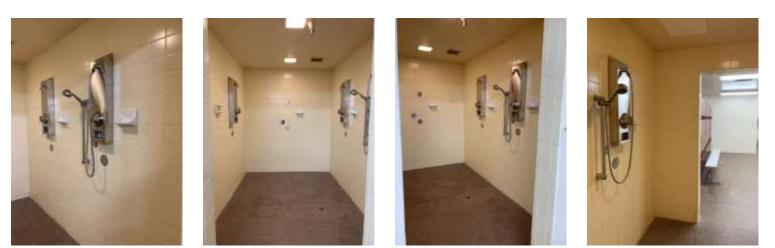
**2010 ADA Standards for Accessible Design Codes:** §608.3.2

There are no grab bars in the roll-in type shower.

Install grab bars on the control wall, side wall, and back wall at 6" maximum from the adjacent walls. Ensure the grab bars are installed at a minimum height of 33" to a maximum height of 36" above the floor.

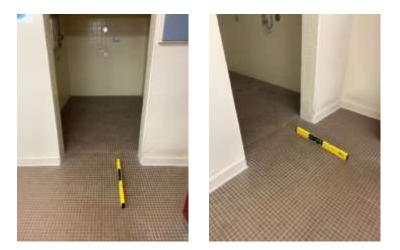
2010 ADA Standards for Accessible Design Codes: §403.3

The running slope is 6.8%.

Reconstruct the route to ensure the slope is a maximum of 2% outside of the shower's threshold.

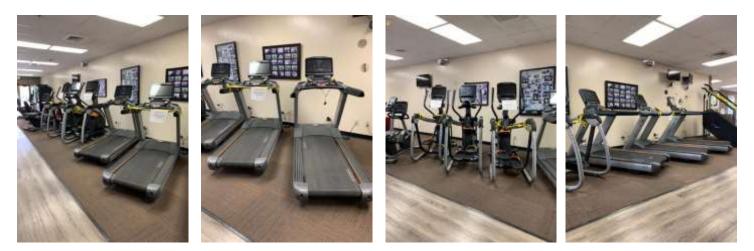
**2010 ADA Standards for Accessible Design Codes:** §305.3

There is not adequate clear floor space to access the cardio machines.

Shift the equipment to ensure that there is a minimum of a 30"x48" space adjacent to the transfer location at each type of machine.

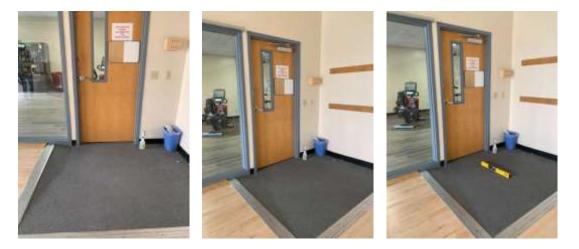
2010 ADA Standards for Accessible Design Codes: §404.2.4.4

The entrance has a 2.9%-3.8% slope.

Resurface the entryway to reduce the running slope to a maximum of 2% in all directions.

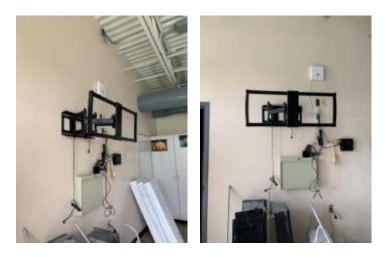
#### **2010 ADA Standards for Accessible Design Codes:** §307.2

The TV stand protrudes 20.75" into the circulation space at 71.5" above the floor.

Recess the TV stand so it protrudes a maximum of 4", raise it so the bottom edge is 80" maximum above the floor, or place a cane detectable object beneath it.

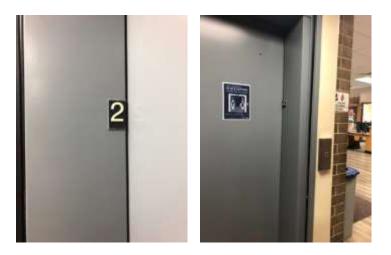
2010 ADA Standards for Accessible Design Codes: §407.2.3.1

There is no tactile star on the door jambs of the main entry level.

Replace the tactile signage on the door jambs of the main entry level with tactile signage containing a tactile star indicating the main entry level.

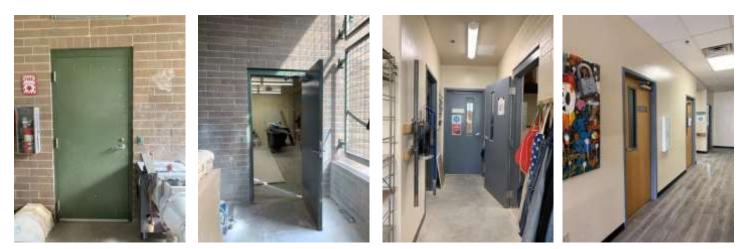
**2010 ADA Standards for Accessible Design Codes:** §216.2, §703

There is no tactile sign identifying 58 permanent room.

Signs shall be Braille with raised lettering and should be placed on the wall in the center of an 18"x18" clear floor space.

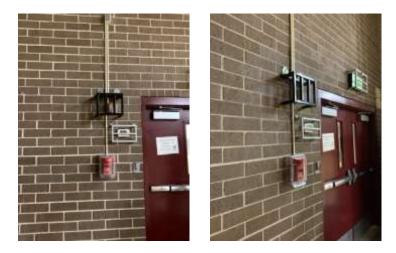
### 2010 ADA Standards for Accessible Design Codes: §307.2

Recess the fire alarm and light switches so they protrude a maximum of 4" or place a cane detectable object beneath them.

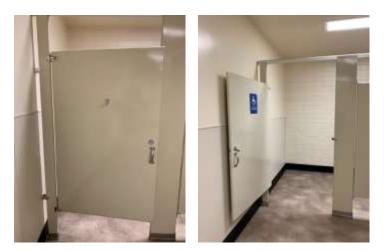
The door to the accessible water closet is not self closing. Either self-closing hinges are not installed on the door or if installed, they are defective.

Install or reinstall self-closing hinges on the door to ensure that the door is self-closing per the ADA requirements.

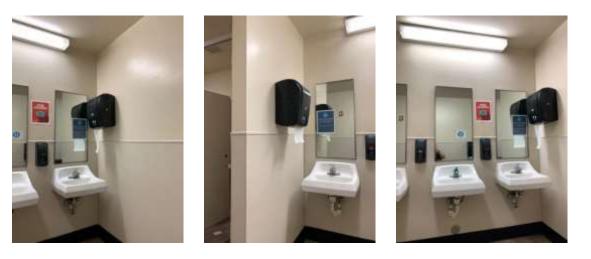
2010 ADA Standards for Accessible Design Codes: §307.2, §308.2.1

Lower the paper towel dispensers by 5.5" and 9.5" to meet the accessible reach range of 15" minimum and 48" maximum above the floor.
