City of Boise

ADA Assessment

AppendixA-Library! At Cole & Ustick

Report #TO21-B016

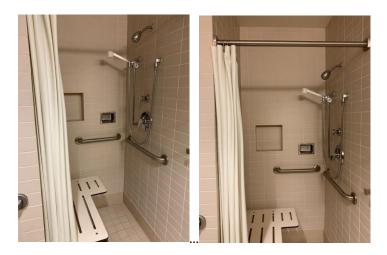
The back wall grab bar is 5" from the control wall.

Install a grab bar across the back wall to a point 18" from the control wall at a maximum height of 36" above the bathroom floor.
