City of Boise ADA
Assessment

Appendix A-Lowell Pool

11/20/2020

Report #TO20-B004

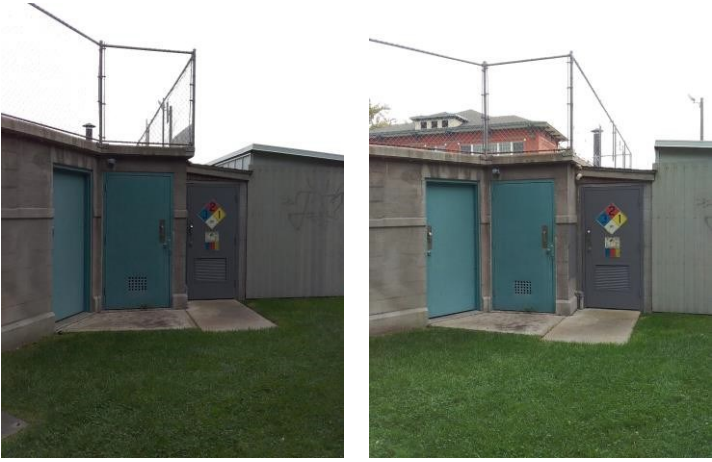
Location: Mechanical Rooms
Schedule: 2021
Estimated Cost: \$200.00

2010 ADA Standards for Accessible Design Codes: §216.2, §703
There is no tactile sign identifying the permanent room.

Install tactile signage on the latch side of the doorway at a height of 48” minimum to 60” maximum above the floor, identifying room by name or room number.
Signs shall be Braille with raised lettering and should be placed on the wall in the center of an 18"x18" clear floor space.

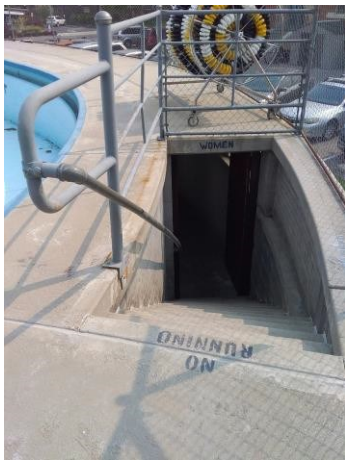
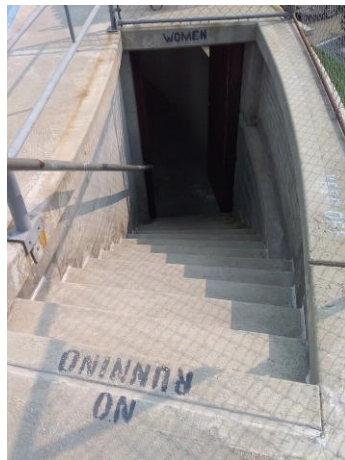
Location: Men and Women's Locker Room

2010 ADA Standards for Accessible Design Codes: §505.4, §505.10.2

Handrails are provided only on one side, and there are no handrail extensions at the top of the stairs. The stair handrails are located 30" and 31" above the stair nosings. Both violations are located outside the men and women's locker rooms.

Install new handrails on both sides of the stairs with extensions that extend at least 12" horizontally above the landing beginning directly above the first stair riser nosing.

Ensure that handrails are installed at a minimum height of 34" and a maximum of 38" above the stair nosings. The height shall be consistent along the stair treads.

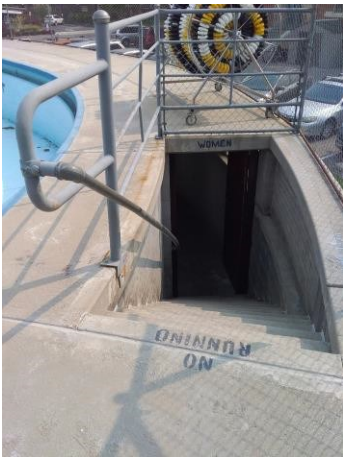
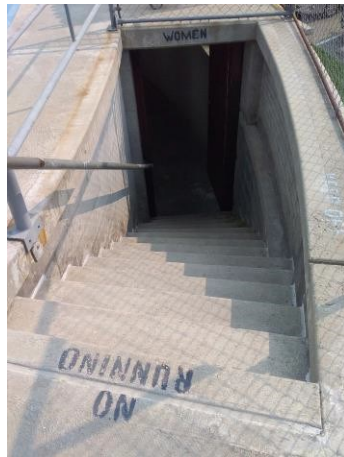
Location: Men and Women's Locker Room

2010 ADA Standards for Accessible Design Codes: §407

The stairs are not accessible for persons in wheelchair.

Construct a 60"x60" elevator with a 36" wide door connecting the pool deck to the proposed accessible locker rooms. Controls shall be installed at 48" maximum above the floor and emergency controls at 38" above the floor. Ensure car position indicators provide verbal announcements of stops. Floor designations shall be provided on both hoistway door jambs and a tactile star shall be provided on the main entry

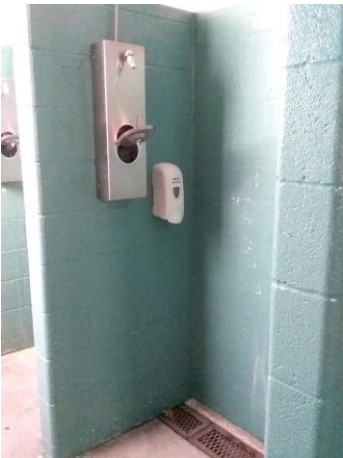
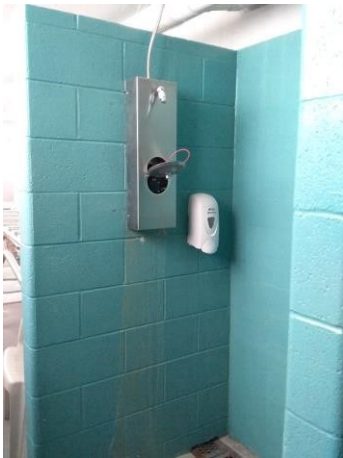
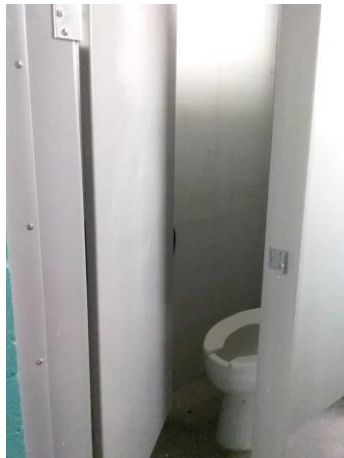
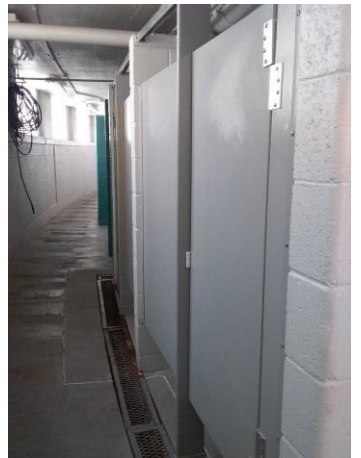
Location: Men and Women's Locker Room
Schedule: 2022
Estimated Cost: \$80,000.00

2010 ADA Standards for Accessible Design Codes: §308, §604, §608

There is not an accessible shower or stall provided in the men and women's locker room. The shower dimensions do not meet the requirements for a transfer type shower at 43"x31". The stalls provided are too small to be accessible.

Due to the historic nature and limited space of the facility, consider constructing an adjacent facility containing an accessible locker rooms, showers, and restroom stalls.

Elements in the accessible shall comply with Section 2.9 of the Lowell Report.

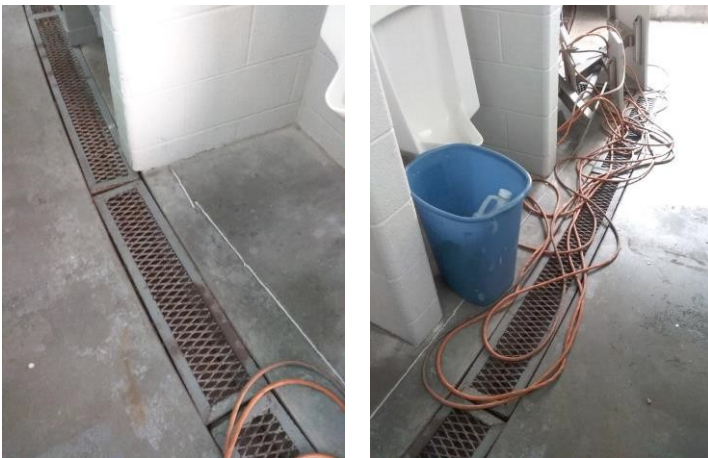
Location: Men and Women's Locker Rooms

2010 ADA Standards for Accessible Design Codes: §302.3

The grates in the men and women's locker room path are not stable.

Replace the grates throughout the locker rooms and ensure that they are secure and stable. Ensure that the openings in the grate is less than 0.5”.

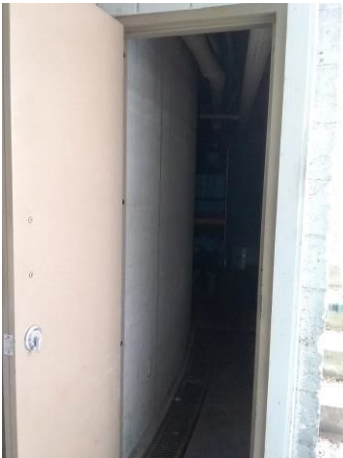
Location: Men's Locker Room

2010 ADA Standards for Accessible Design Codes: §216.2, §703

There is no tactile sign identifying the permanent room.

Install tactile signage on the latch side of the doorway at a height of 48” minimum to 60” maximum above the floor, identifying room by name or room number.

Signs shall be Braille with raised lettering and should be placed on the wall in the center of an 18"x18" clear floor space.

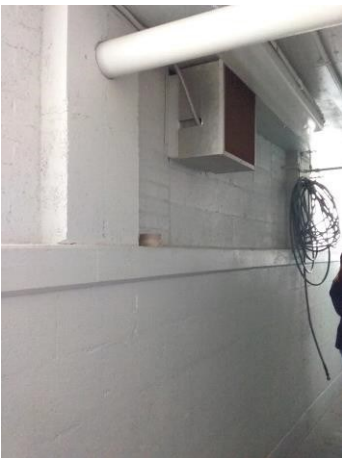
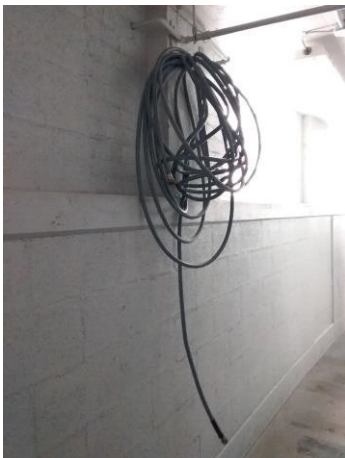
Location: Men's Locker Room
Schedule: 2022
Estimated Cost: \$200.00

2010 ADA Standards for Accessible Design Codes: §307.2
The hose protrudes 6" into the circulation space at 63" above the floor.
The air conditioning unit protrudes 7" into the circulation space at 78" above the floor.

Recess the hose and air conditioning unit so they protrude a maximum of 4", lower them so the bottom edge is 27" maximum above the floor, or place a cane detectable object beneath it.

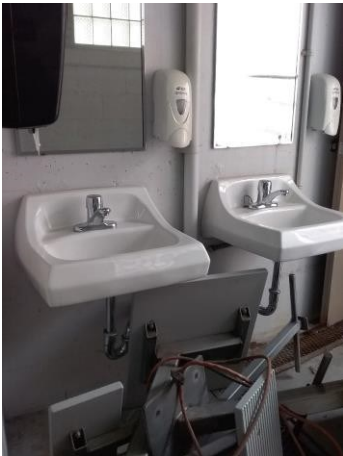
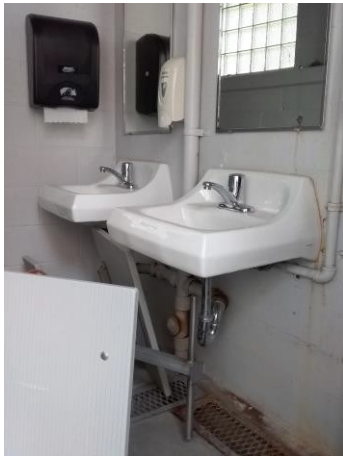
Location: Men's Locker Room

2010 ADA Standards for Accessible Design Codes: §606.5

The pipes under the sink are not covered.

Wrap the pipes beneath the sink with soft protective wrap or plastic.

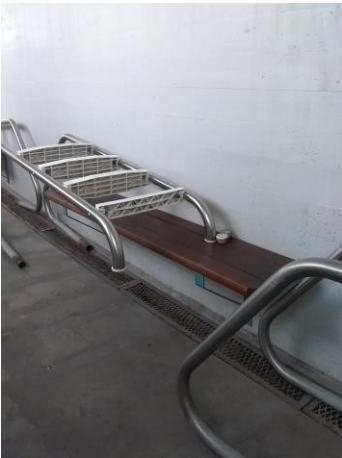
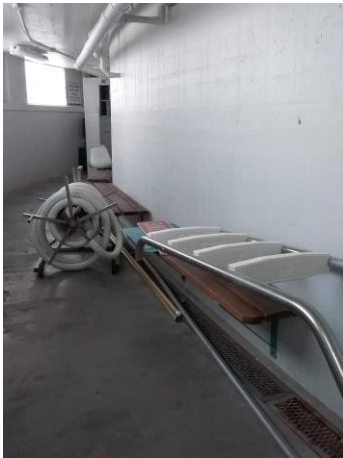
Location: Men's Locker Room
Schedule: 2022
Estimated Cost: \$1,000.00

2010 ADA Standards for Accessible Design Codes: §903.3
The benches in the men's locker room are 14" deep.

Install a new accessible bench that is at least 42" long and 20" minimum to 24" maximum deep.

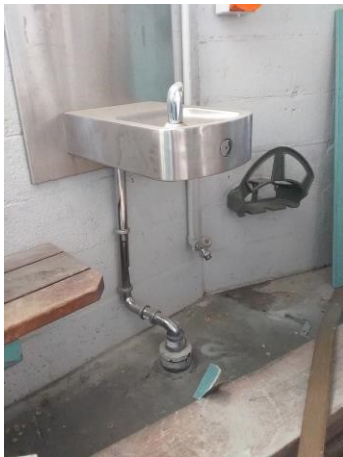
Location: Men's Locker Room

2010 ADA Standards for Accessible Design Codes: §211.2, §307.2, §602.7

There is only one drinking fountain in the men's locker room provided at 33" above the floor. The drinking fountain protrudes 16" into the circulation path.

Install an additional drinking fountain at a minimum height of 38" and maximum of 43" above the floor.

Place a drinking fountain skirt at this location to provide cane detectability.

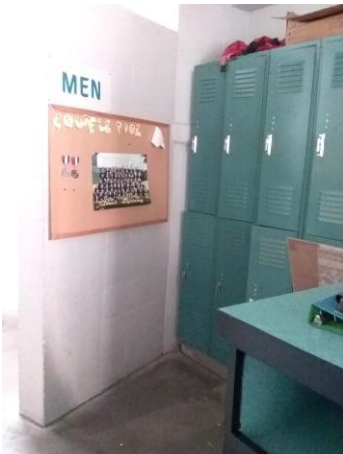
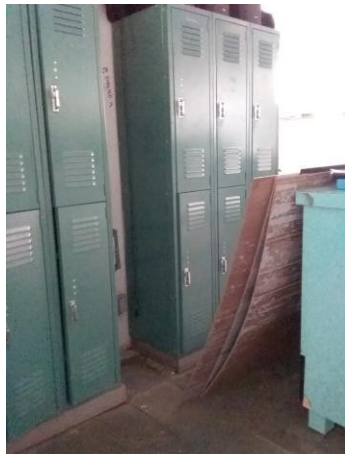
Location: Men's Locker Room

2010 ADA Standards for Accessible Design Codes: §304.3.1

There is not an adequate turning space in the men's locker room.

Expand the space to provide a Circular or T-Shaped turning space. The circular turning space shall have a minimum diameter of 60".

The T-Shaped space shall be 60" square minimum with arms and base 36" wide minimum. Each arm shall be clear of obstructions 12" minimum in each direction. The base shall be clear of obstruction 24" minimum.

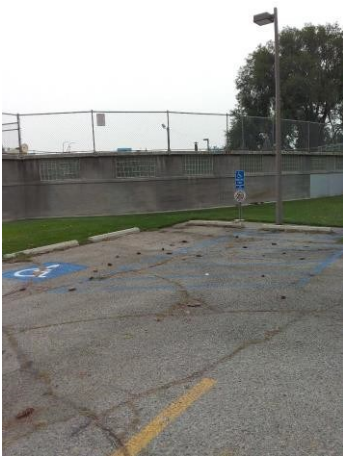
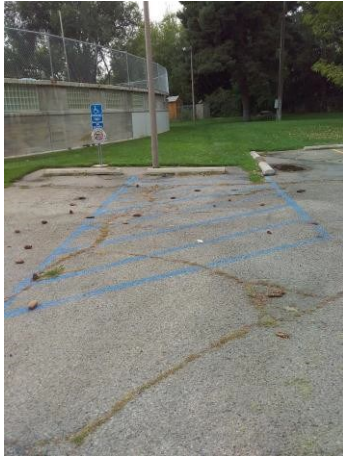
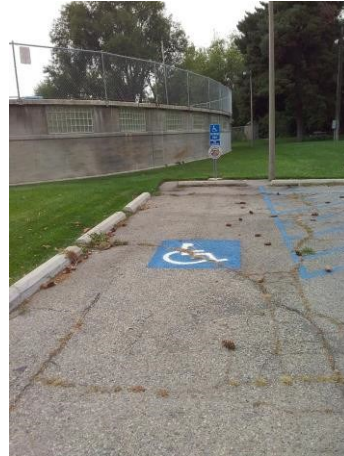
Location: Parking Lot

2010 ADA Standards for Accessible Design Codes: §502.6

The accessible parking sign is 46" above the floor.

Remount the accessible parking sign at a minimum height of 60" above the ground.

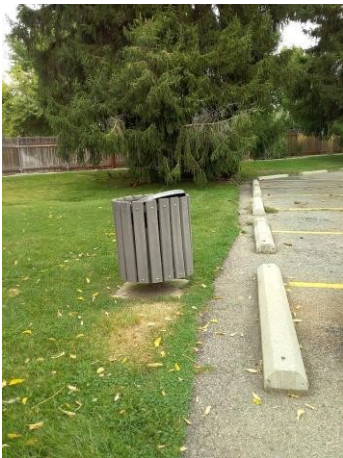
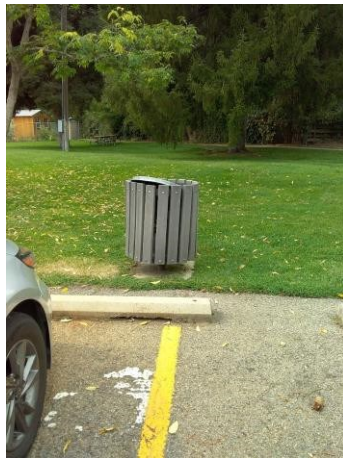
Location: Parking Lot

2010 ADA Standards for Accessible Design Codes: §302.1, §305

There is not a firm, stable, and slip resistant route to the garbage can. There is no clear floor space to access the garbage can.

Relocate the garbage to be adjacent to the accessible route or another firm, stable, and slip resistant surface with clear floor space of 30"x48". Ensure that the clear floor space has a maximum slope of 2% in all directions.

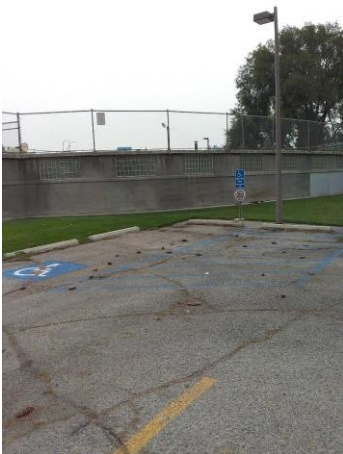
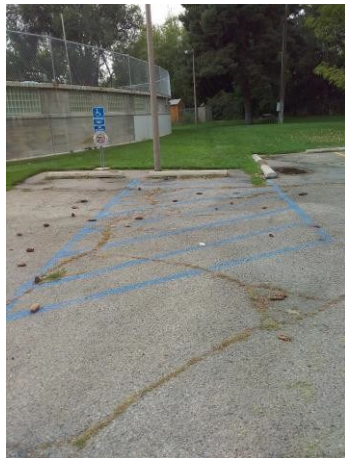
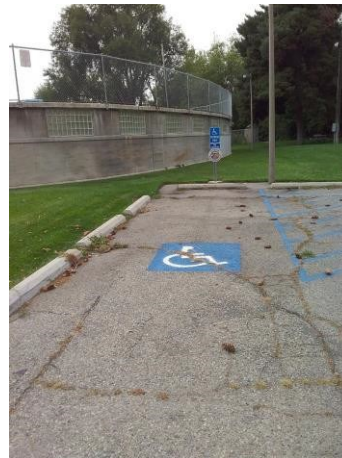
Location: Parking Lot

2010 ADA Standards for Accessible Design Codes: §303.2

There is a change in level greater than 0.25" in the accessible parking space and access aisle creating tripping hazards.

Resurface the parking spaces and access aisle to reduce the changes in level to less than 0.25".

Ensure that there is a maximum slope of 2% in all directions.

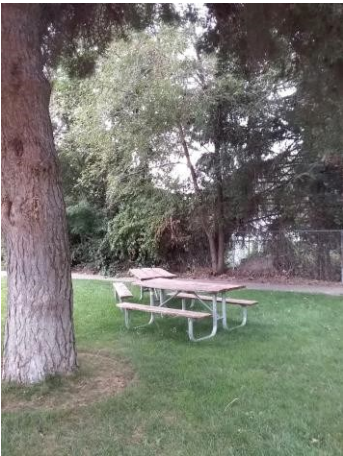
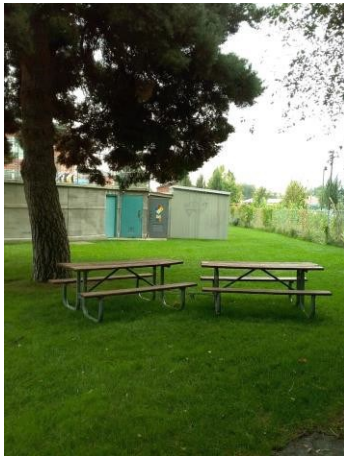
Location: Picnic Tables
Schedule: 2022
Estimated Cost: \$5,000.00

2010 ADA Standards for Accessible Design Codes: §302.1, §305, §902.4
The picnic tables are not compliant because there is no wheelchair seating available. There is not a firm, stable, and slip resistant route to the picnic tables.

Install a new accessible picnic table at a minimum height of 28" and maximum of 34". Provide knee clearance that is a minimum of 11" deep at 9" above the floor and 8" deep at 27" above the floor.
Construct a firm, stable, and slip resistant accessible route with a maximum cross slope of 2% and maximum running slope of 5%.

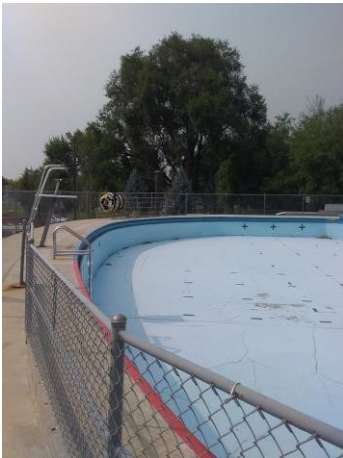
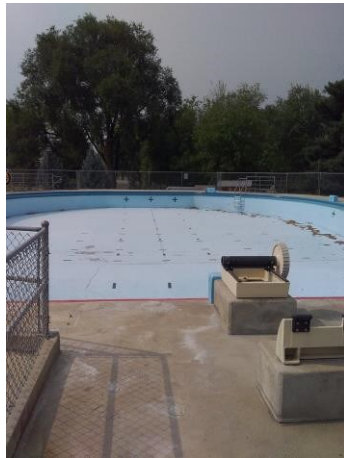
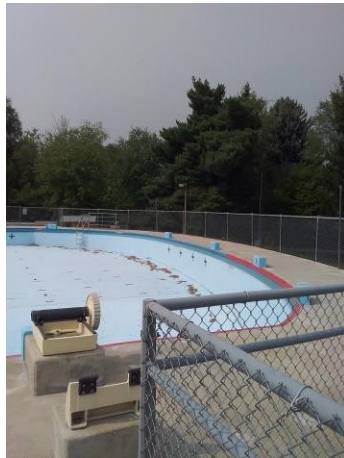
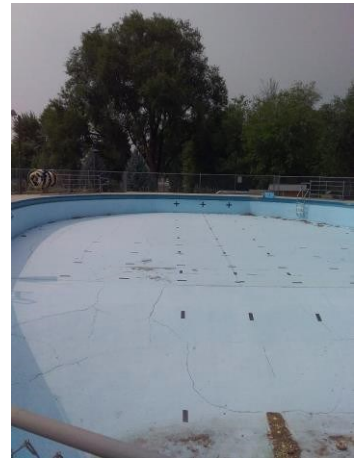
Location: Pool Deck

2010 ADA Standards for Accessible Design Codes: §242.2, §1009

The pool has a circumference of approximately 250 linear feet with no accessible means of entry from the deck into the water.

Install a pool lift complying with §1009. Ensure that adjacent to the lift is a 30"x48" clear floor space with a maximum slope of 2% in all directions.

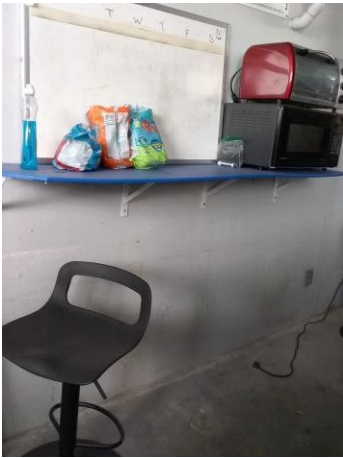
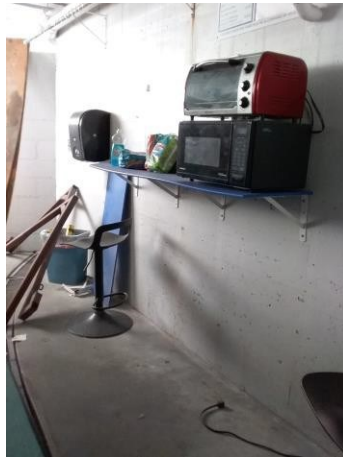
Location: Pool Entrance Check-In Area

2010 ADA Standards for Accessible Design Codes: §308.2.1

The microwave is outside of the unobstructed forward reach range at 49" above the floor.

Lower the microwave by 1" to meet the accessible reach range of 15" minimum and 48" maximum above the floor.

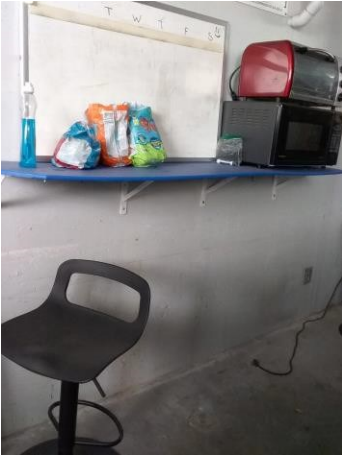
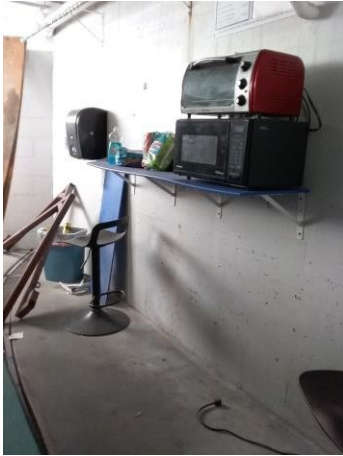
Location: Pool Entrance Check-In Area
Schedule: 2023
Estimated Cost: \$100.00

2010 ADA Standards for Accessible Design Codes: §308.2.1
The toaster is outside of the unobstructed forward reach range at 58" above the floor.

Lower the toaster by 10" to meet the accessible reach range of 15" minimum and 48" maximum above the floor.

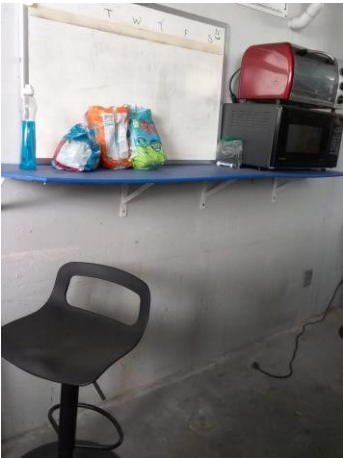
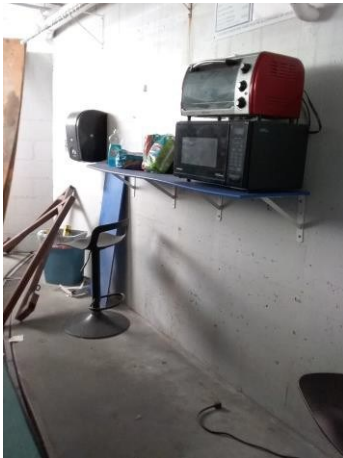
Location: Pool Entrance Check-In Area
Schedule: 2022
Estimated Cost: \$100.00

2010 ADA Standards for Accessible Design Codes: §307.2
The shelf protrudes 15" into the circulation space at 43" above the floor.

Place a cane detectable object on either edge of the shelf.

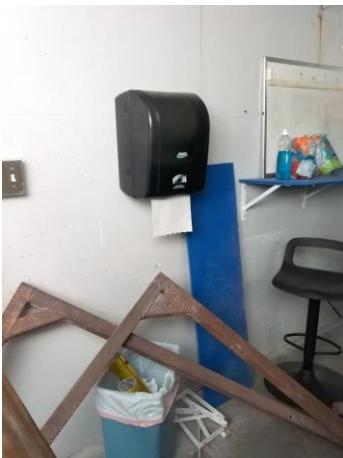
Location: Pool Entrance Check-In Area

2010 ADA Standards for Accessible Design Codes: §307.2

The paper towel dispenser protrudes 8" into the circulation space at 44" above the floor.

Recess the paper towel dispenser so it protrudes a maximum of 4", lower it so the bottom edge is 27" maximum above the floor, or place a cane detectable object beneath it.

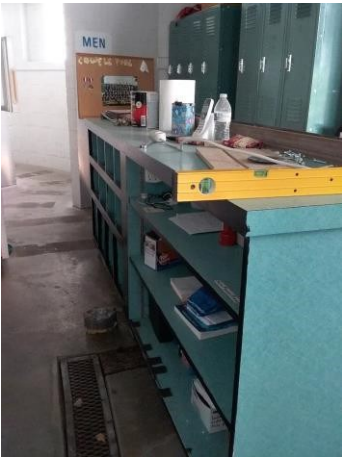
Location: Pool Entrance Check-In Area
Schedule: 2021
Estimated Cost: \$1,000.00

2010 ADA Standards for Accessible Design Codes: §904.4.1
The counter in the pool entrance check-in area is 42" above the floor.

Lower a section of the counter by at least 6" to meet the required maximum height of 36" above the finish floor for a horizontal distance of 36".

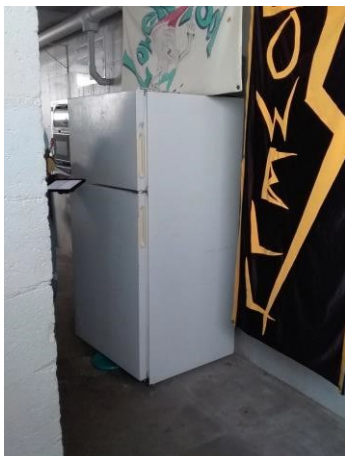
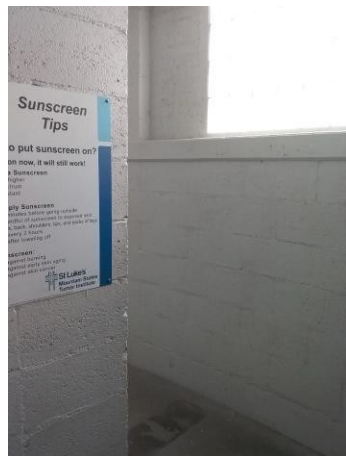
Location: Pool Entrance Check-In Area

2010 ADA Standards for Accessible Design Codes: §304.3.1

There is not an adequate turning space in the check-in area.

Expand the space to provide a Circular or T-shaped turning space. The circular turning space shall have a minimum diameter of 60".

The T-Shaped space shall be 60" square minimum with arms and base 36" wide minimum. Each arm shall be clear of obstructions 12" minimum in each direction. The base shall be clear of obstruction 24" minimum.

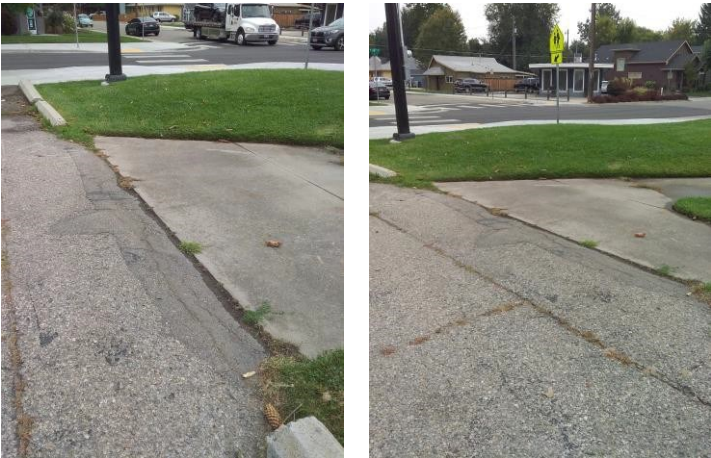
Location: Route from Parking to the Entrance
Schedule: 2021
Estimated Cost: \$5,000.00

2010 ADA Standards for Accessible Design Codes: §403.3
 The running slope of the route connecting the accessible parking space to the entrance reaches 15%.

Resurface the route to reduce the running slope to a maximum of 5%. Ensure that the cross slope is a maximum of 2%.

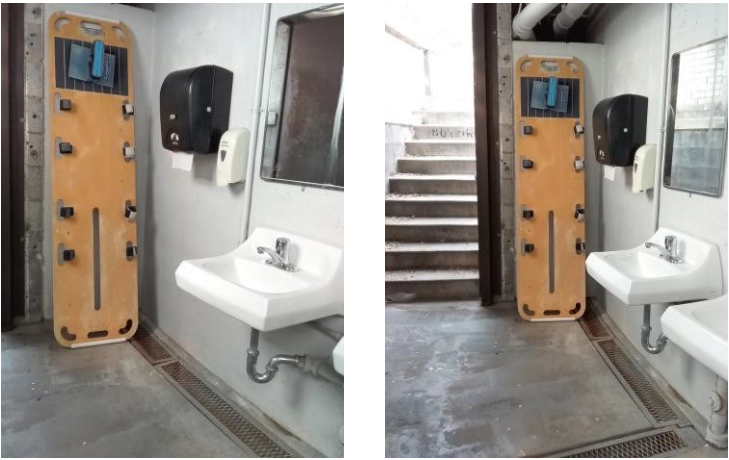
Location: Women's Locker Room
Schedule: 2022
Estimated Cost: \$100.00

2010 ADA Standards for Accessible Design Codes: §307.2
The paper towel dispenser protrudes 8" into the circulation space at 48" above the floor.

Recess the paper towel dispenser so it protrudes a maximum of 4", lower it so the bottom edge is 27" maximum above the floor, or place a cane detectable object beneath it.

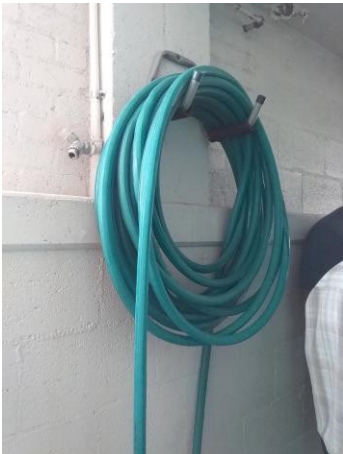
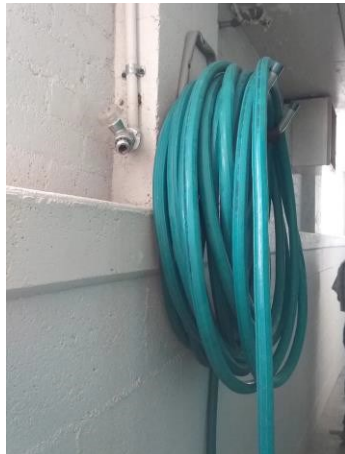
Location: Women's Locker Room

2010 ADA Standards for Accessible Design Codes: §307.2, §308.2.1

The hose and hooks holding them are outside of the unobstructed forward reach range at 50" above the floor and protrude into the circulation space.

Lower the hooks by 2" to meet the accessible reach range of 15" minimum and 48" maximum above the floor.

Recess the hose to protrude a maximum of 4", lower it so the bottom edge is 27" maximum above the floor, or place a cane detectable object beneath it.

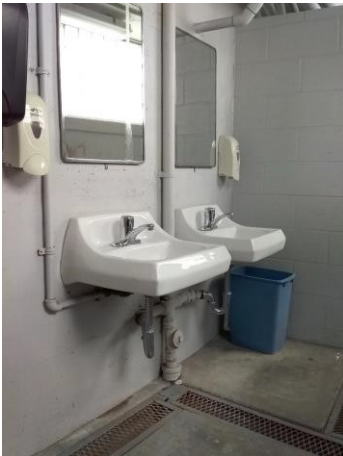
Location: Women's Locker Room

2010 ADA Standards for Accessible Design Codes: §606.5

The pipes under the sinks are not covered.

Wrap the pipes beneath the sinks with soft protective wrap or plastic.

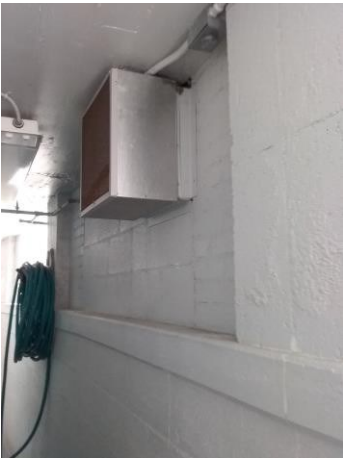
Location: Women's Locker Room
Schedule: 2022
Estimated Cost: \$500.00

2010 ADA Standards for Accessible Design Codes: §307.2
The electrical box in the women's locker room protrudes 7" into the circulation space at 78" above the floor.

Recess the electrical box so it protrudes a maximum of 4", or place a cane detectable object beneath it.

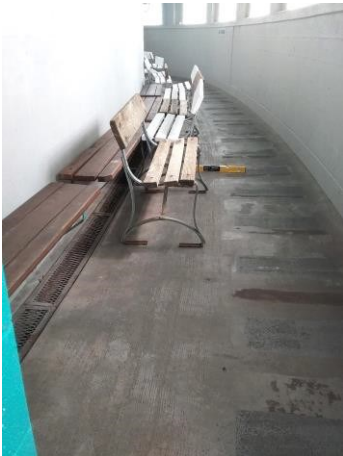
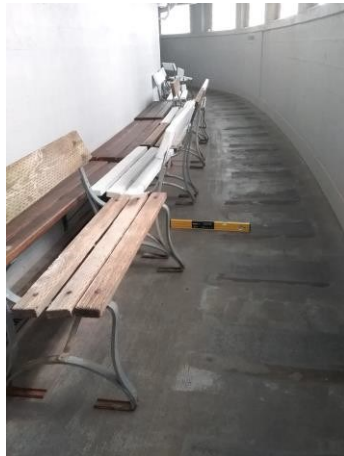
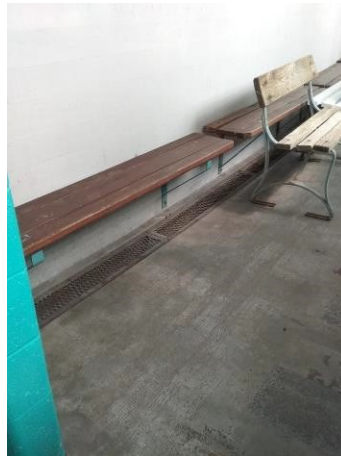
Location: Women's Locker Room

2010 ADA Standards for Accessible Design Codes: §403.3

The cross slope is 2.3% throughout the Women's Locker Room.

Resurface the route to reduce the cross slope to a maximum of 2%.

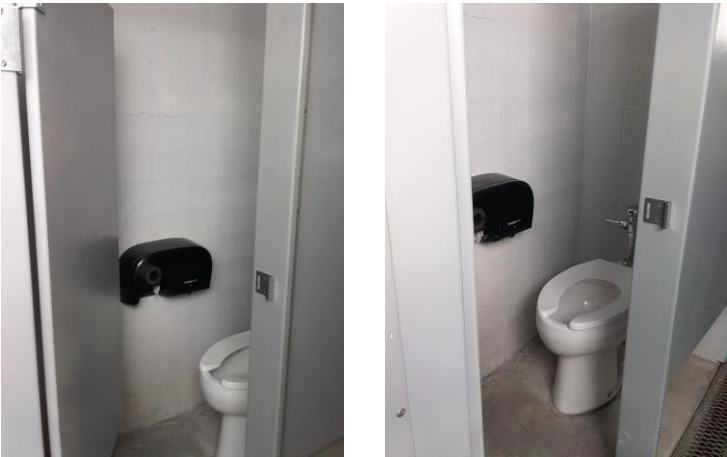
Location: Women's Locker Room
Schedule: 2022
Estimated Cost: \$20,000.00

2010 ADA Standards for Accessible Design Codes: §213.3.1, §604
There is not an accessible stall in the women's locker room.

Due to space constraints, construct an accessible exterior restroom as suggested in Section 2.9 of the Lowell Report at least 60" deep and 35" to 37" wide.
