City of Boise
ADA Assessment

Lowell Pool

11/20/2020

Report #TO20-B004

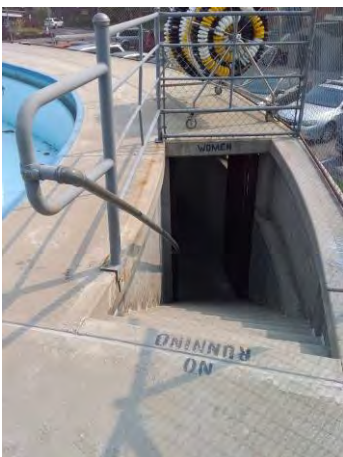
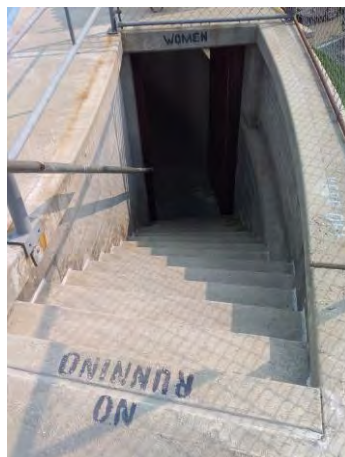
ID:
3283

Handrails are provided only on one side, and there are no handrail extensions at the top of the stairs. The stair handrails are located 30" and 31" above the stair nosings. Both violations are located outside the men and women's locker rooms.

Install new handrails on both sides of the stairs with extensions that extend at least 12" horizontally above the landing beginning directly above the first stair riser nosing.

Ensure that handrails are installed at a minimum height of 34" and a maximum of 38" above the stair nosings. The height shall be consistent along the stair treads.

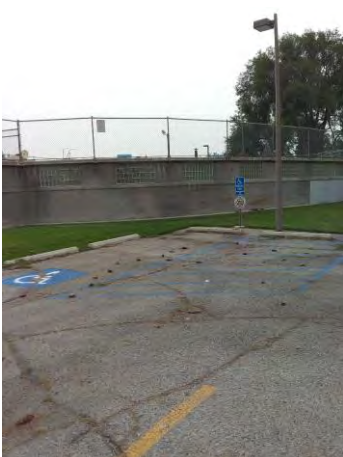
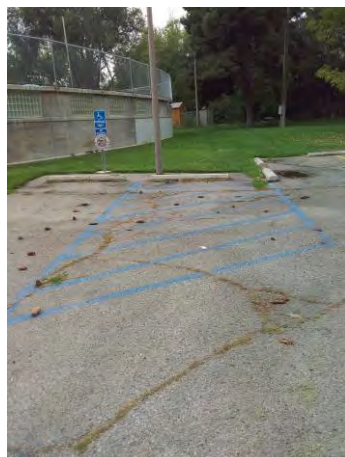
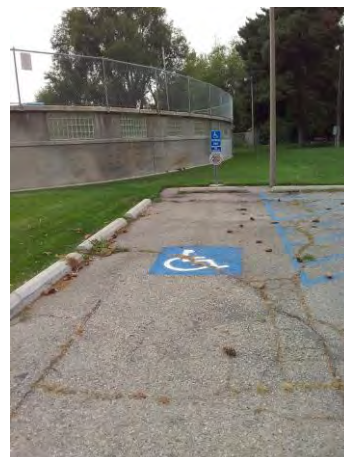
ID:
3426

There is a change in level greater than 0.25" in the accessible parking space and access aisle creating tripping hazards.

Resurface the parking spaces and access aisle to reduce the changes in level to less than 0.25".

Ensure that there is a maximum slope of 2% in all directions.
