# FACILITIES ASSESSMENT

## South and Lowell City Pools

Structural Assessment February 2022

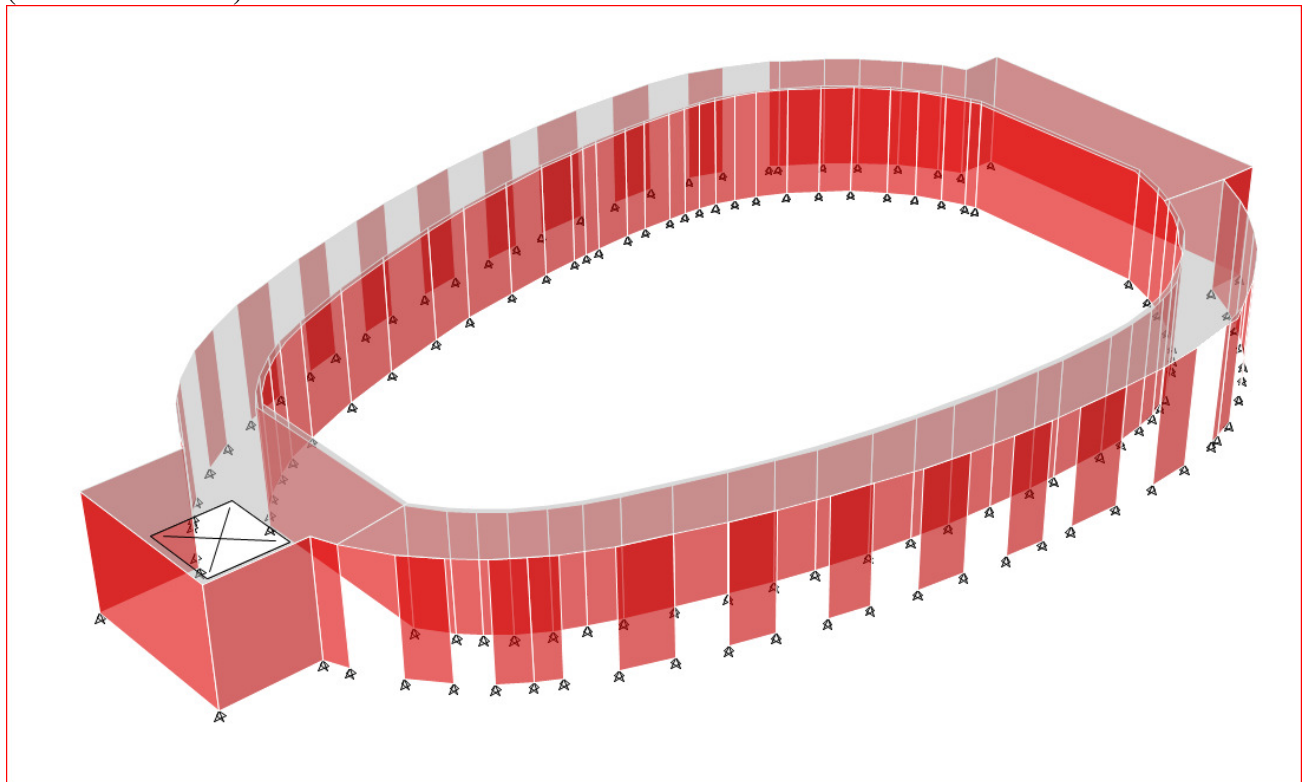
**Figure 7: 3D View of ETABS Design Model of Structure**

Based on this finite element analysis, the existing walls of the pool were found to have adequate strength as the pool walls are below threshold level stresses that would cause the walls to experience cracking and deformation.
