City of Boise
ADA Assessment

Appendix A–Boise Urban Garden School

12/30/2020

Report #TO21-B011

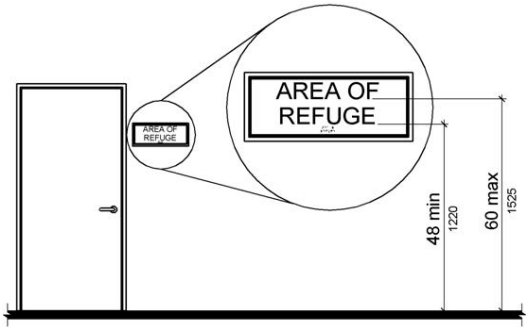
ID: 1850 **Facility:** Boise Urban Garden School

2010 ADA Standards for Accessible Design Codes: §216.2, §703
There is no tactile sign identifying the permanent room.

Install tactile signage on the latch side of the doorway at a height of 48" minimum to 60" maximum above the floor, identifying room by name or room number.
Signs shall be Braille with raised lettering and should be placed on the wall in the center of an 18"x18" clear floor space.

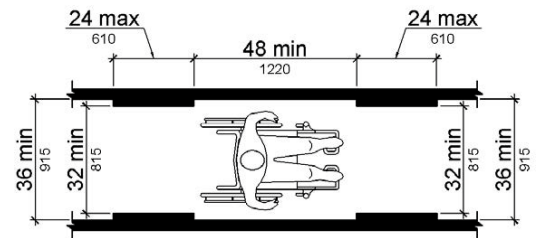
ID: 1870 **Facility:** Boise Urban Garden School

2010 ADA Standards for Accessible Design Codes: §403.5.1
Due to the foliage, there is not a clear 36" width for wheelchairs to pass.

Trim and continue to maintain the foliage as to keep it out of the accessible route.

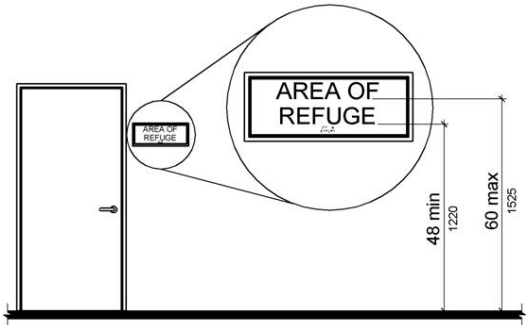
ID: 1873 **Facility:** Boise Urban Garden School

2010 ADA Standards for Accessible Design Codes: §216.2, §703
There is no tactile sign identifying the permanent room.

Install tactile signage on the latch side of the doorway at a height of 48” minimum to 60” maximum above the floor, identifying room by name or room number.
Signs shall be Braille with raised lettering and should be placed on the wall in the center of an 18"x18" clear floor space.

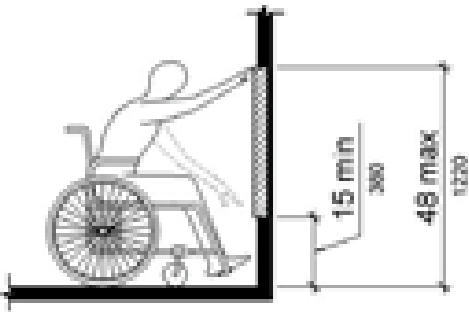
ID: 1878 **Facility:** Boise Urban Garden School

2010 ADA Standards for Accessible Design Codes: §308.2.1
The hooks are outside of the unobstructed forward reach range at 50.5" above the floor.

Lower the hooks by 2.5" to meet the accessible reach range of 48" maximum above the floor.

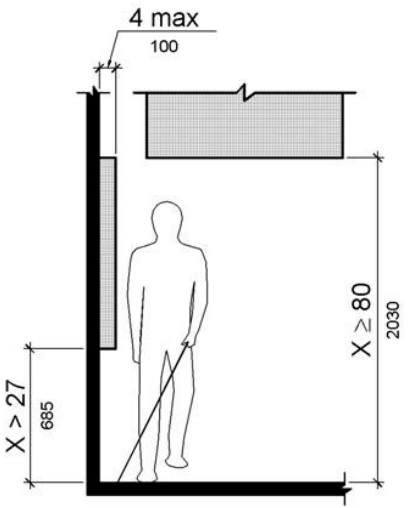
ID: 1888 **Facility:** Boise Urban Garden School

2010 ADA Standards for Accessible Design Codes: §307.2
The silver fire extinguisher protrudes 7" into the circulation space at 29.25" above the floor.

Recess the silver fire extinguisher so it protrudes a maximum of 4", lower it so the bottom edge is 27" maximum above the floor, or place a cane detectable object beneath it.

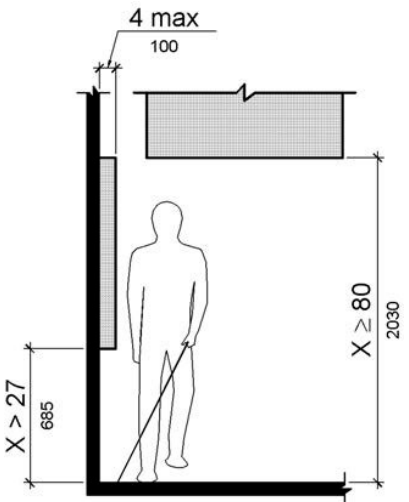
ID: 1889 **Facility:** Boise Urban Garden School

2010 ADA Standards for Accessible Design Codes: §307.2
The red fire extinguisher protrudes 4.25" into the circulation space at 33.5" above the floor.

Recess the red fire extinguisher so it protrudes a maximum of 4", lower it so the bottom edge is 27" maximum above the floor, or place a cane detectable object beneath it.

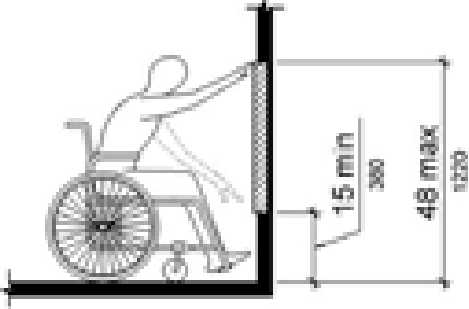
ID: 1890 **Facility:** Boise Urban Garden School

2010 ADA Standards for Accessible Design Codes: §308.2.1, §307.2
 The first aid box protrudes 5.5" into the circulation space at 54.75" above the floor.
 The first aid box is outside of the unobstructed forward reach range at 54.75" above the floor.

Recess the first aid box so it protrudes a maximum of 4", lower it so the bottom edge is 27" maximum above the floor, or place a cane detectable object beneath it.
 Lower the first aid box by 6.75" to meet the accessible reach range of 15" minimum and 48" maximum above the floor.

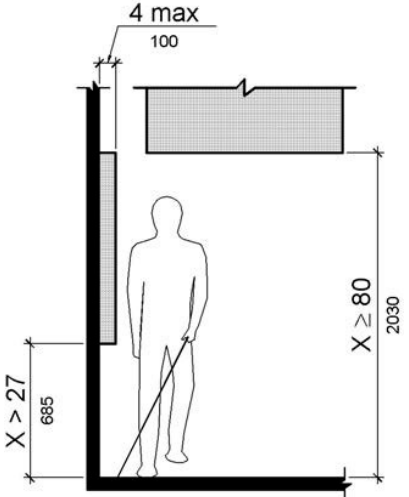
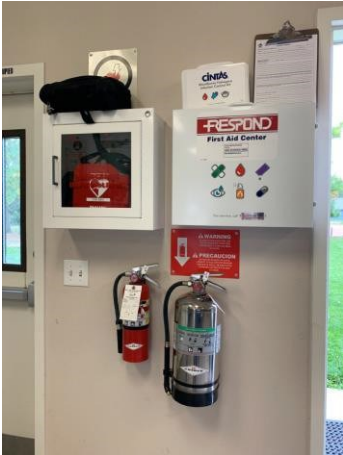
ID: 1891 **Facility:** Boise Urban Garden School

2010 ADA Standards for Accessible Design Codes: §307.2, §308.2.1
The AED is outside of the unobstructed forward reach range at 54.25" above the floor. The AED protrudes 7" into the circulation space at 54.25" above the floor.

Lower the AED by 6.25" to meet the accessible reach range of 15" minimum and 48" maximum above the floor.
Recess the AED so it protrudes a maximum of 4", lower it so the bottom edge is 27" maximum above the floor, or place a cane detectable object beneath it.

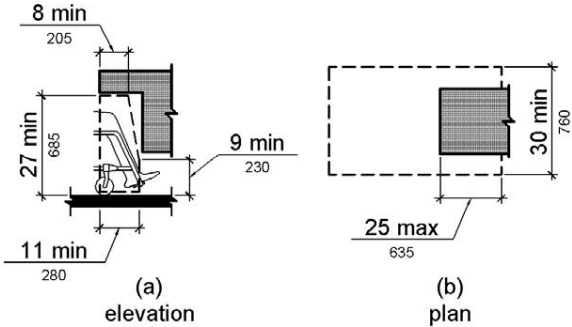
ID: 1876 **Facility:** Boise Urban Garden School

2010 ADA Standards for Accessible Design Codes: §902.3, §306.3.3
There is no knee clearance underneath the sink.
The sink and work surface counter is 36" above the floor.

Provide knee clearance underneath the counter at the sink that is a minimum of 11" deep at 9" above the floor and 8" deep at 27" above the floor.
A 30" portion of the work surface must be no higher than 34" above the floor. Lower the sink to the maximum height of 34" above the floor.

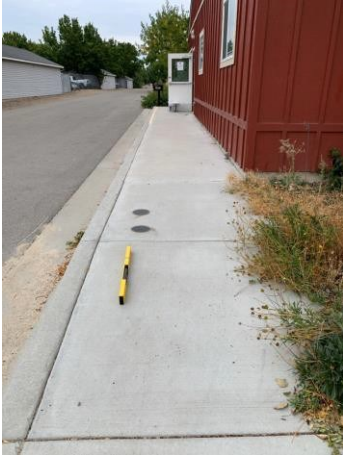
2010 ADA Standards for Accessible Design Codes: §403.3
The running slope is 8.5%.

Although this sidewalk follows the slope of the adjacent road, it would provide greater access if the slope were reduced.
Consider reconstructing this portion of the sidewalk to have a maximum running slope of 5%.
