City of Boise ADA
Assessment

Appendix A-Lowell Pool

11/20/2020

Report #TO20-B004

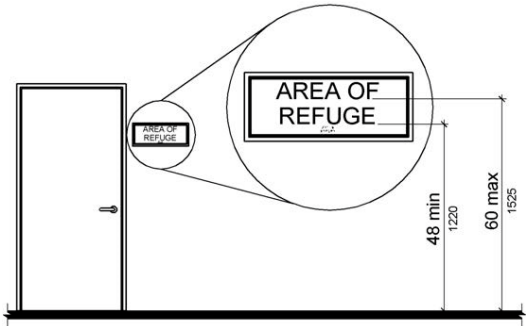
Location: Mechanical Rooms
Schedule: 2021
Estimated Cost: \$200.00

2010 ADA Standards for Accessible Design Codes: §216.2, §703
There is no tactile sign identifying the permanent room.

Install tactile signage on the latch side of the doorway at a height of 48” minimum to 60” maximum above the floor, identifying room by name or room number.
Signs shall be Braille with raised lettering and should be placed on the wall in the center of an 18"x18" clear floor space.

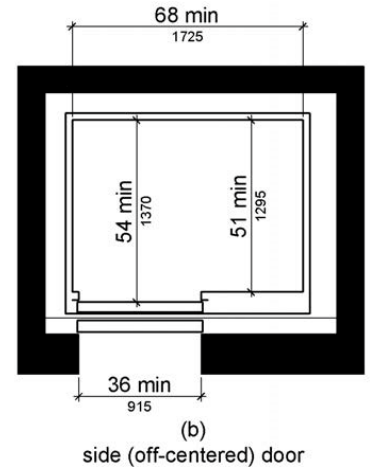
Location: Men and Women's Locker Room

2010 ADA Standards for Accessible Design Codes: §407

The stairs are not accessible for persons in wheelchair.

Construct a 60"x60" elevator with a 36" wide door connecting the pool deck to the proposed accessible locker rooms. Controls shall be installed at 48" maximum above the floor and emergency controls at 38" above the floor. Ensure car position indicators provide verbal announcements of stops. Floor designations shall be provided on both hoistway door jambs and a tactile star shall be provided on the main entry

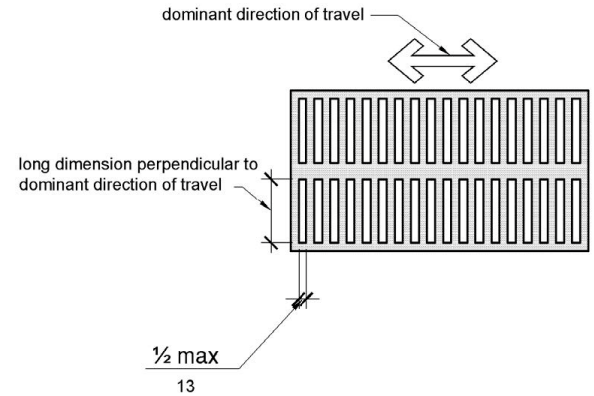
Location: Men and Women's Locker Rooms

2010 ADA Standards for Accessible Design Codes: §302.3

The grates in the men and women's locker room path are not stable.

Replace the grates throughout the locker rooms and ensure that they are secure and stable. Ensure that the openings in the grate is less than 0.5”.

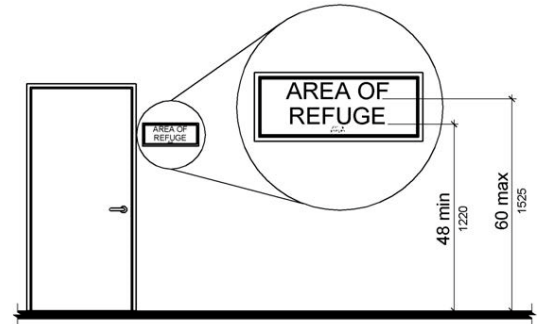
Location: Men's Locker Room

2010 ADA Standards for Accessible Design Codes: §216.2, §703

There is no tactile sign identifying the permanent room.

Install tactile signage on the latch side of the doorway at a height of 48” minimum to 60” maximum above the floor, identifying room by name or room number.

Signs shall be Braille with raised lettering and should be placed on the wall in the center of an 18"x18" clear floor space.

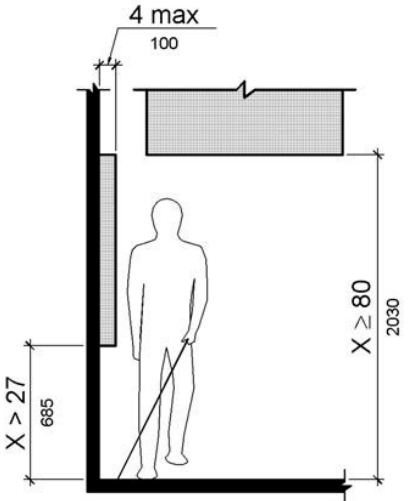
Location: Men's Locker Room
Schedule: 2022
Estimated Cost: \$200.00

2010 ADA Standards for Accessible Design Codes: §307.2
The hose protrudes 6" into the circulation space at 63" above the floor.
The air conditioning unit protrudes 7" into the circulation space at 78" above the floor.

Recess the hose and air conditioning unit so they protrude a maximum of 4", lower them so the bottom edge is 27" maximum above the floor, or place a cane detectable object beneath it.

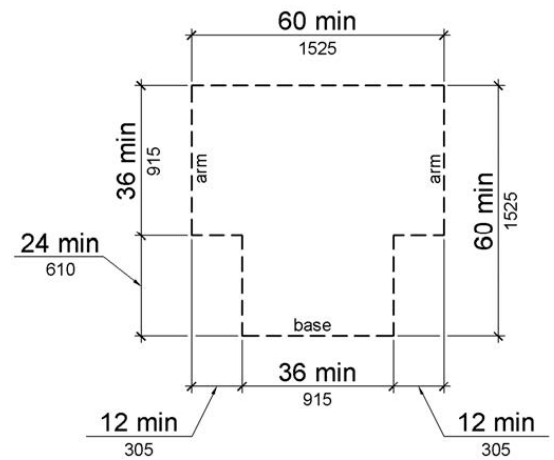
Location: Men's Locker Room

2010 ADA Standards for Accessible Design Codes: §304.3.1

Expand the space to provide a Circular or T-Shaped turning space. The circular turning space shall have a minimum diameter of 60".

The T-Shaped space shall be 60" square minimum with arms and base 36" wide minimum. Each arm shall be clear of obstructions 12" minimum in each direction. The base shall be clear of obstruction 24" minimum.
